Fluvial Geomorphology Report

in support of a
Master Environmental Servicing Plan
4134 16th Avenue, City of Markham

Sixteenth Land Holdings Inc.

November 2017 215200.1

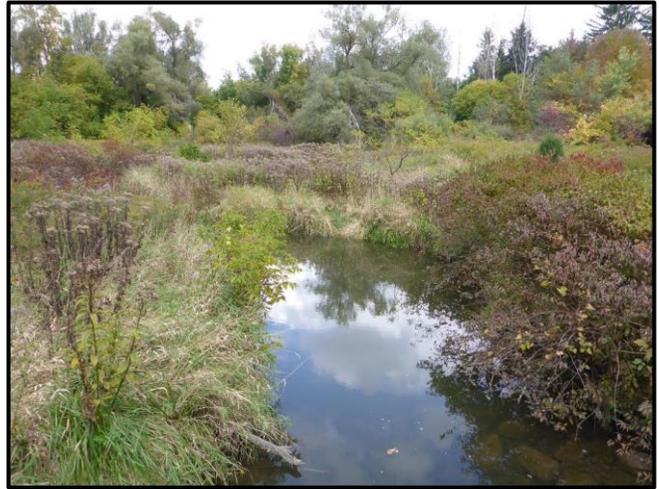
Photo 2

BR-2. Upstream view from pedestrian trail crossing at downstream reach extent.

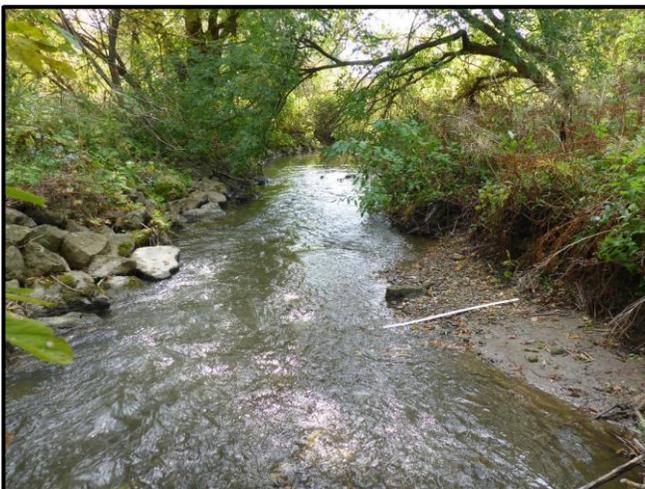
Photo 2

BR-2. Downstream view of general channel conditions. Note stone bank protection on left bank.

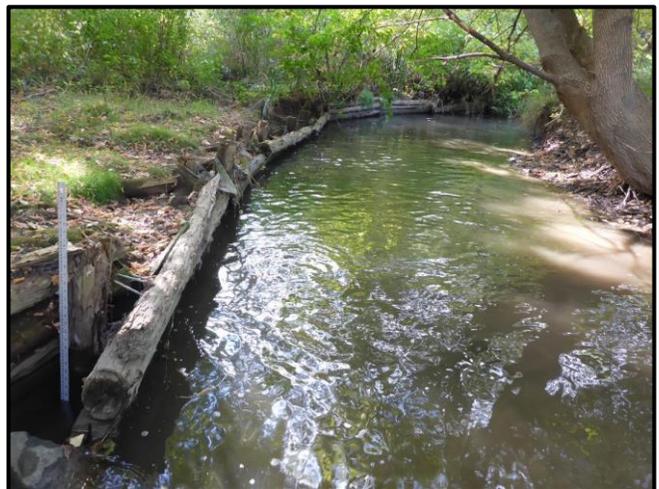
Photo 4

BR-2. Looking upstream at failing (undermined and outflanked) cribwall along outside meander bend.

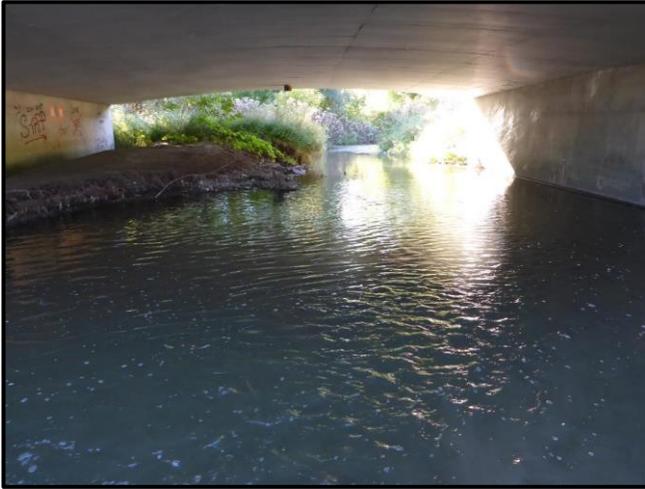
Photo 5
BR-2. Downstream view under 16th Avenue crossing.

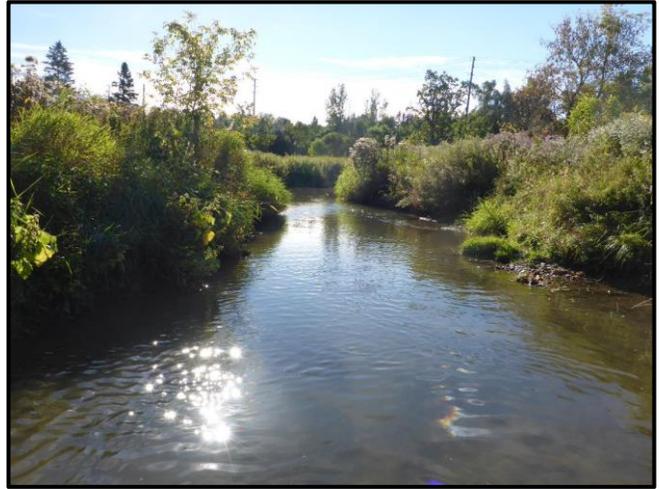
Photo 6
BR-2. Basal scour on both side through riffle.

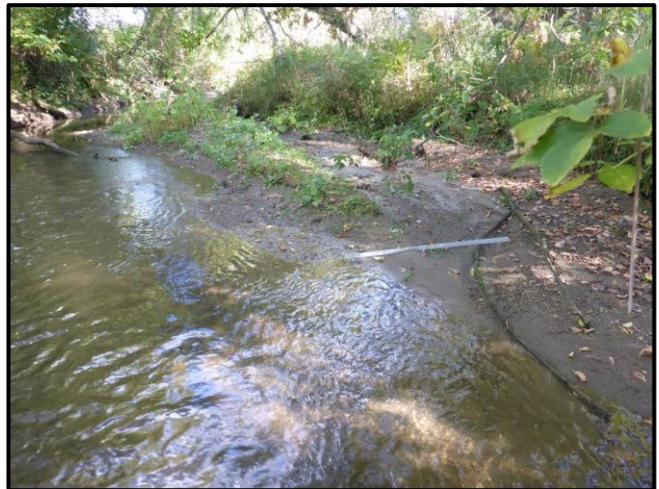
Photo 8
BR-2. Vegetated bar with chute formation viewed upstream.

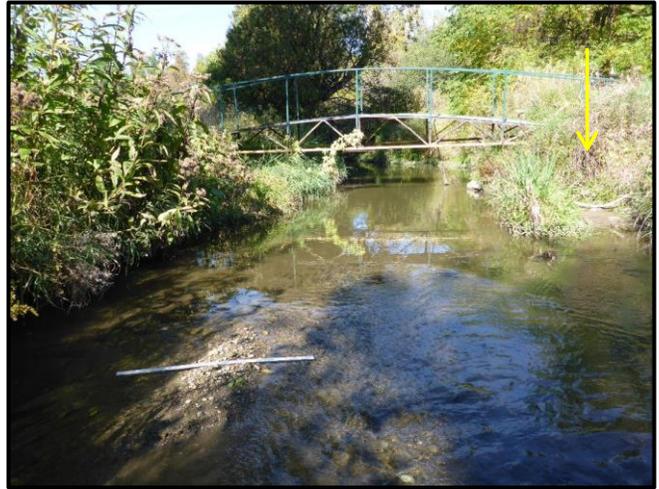
Photo 14
BR-2. Looking upstream at pedestrian crossing at upstream extent of the reach. Note the slumping with chute formation in behind.

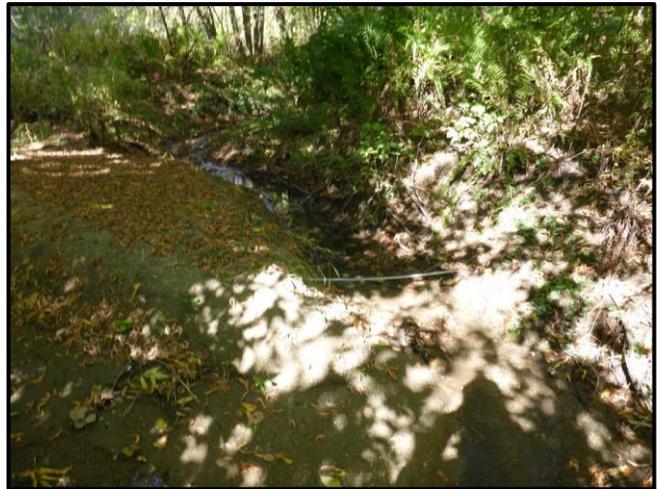
Photo 16
BR-3. Looking downstream confluence with surface flow feature. Note large sand deposit.

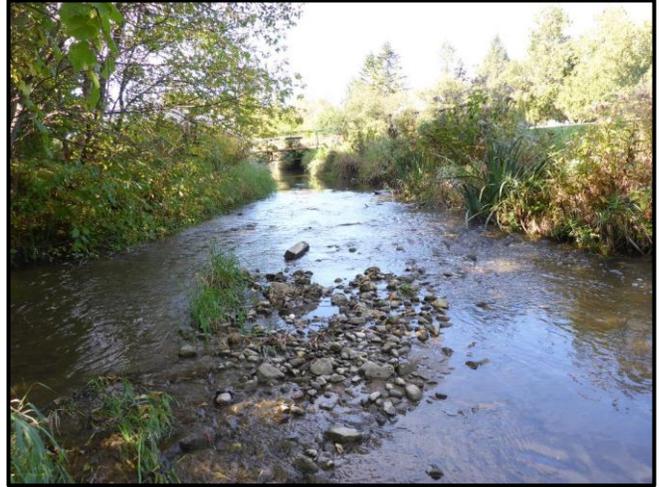
Photo 18
BR-3. Looking upstream pedestrian crossing. Note gravel bar within the channel.

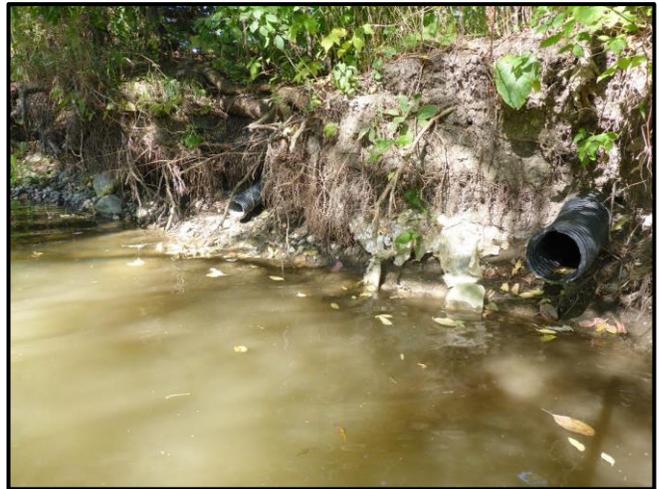
Photo 20
BR-3. Looking upstream at exposed previously buried pipes in left bank (photo right/centre).

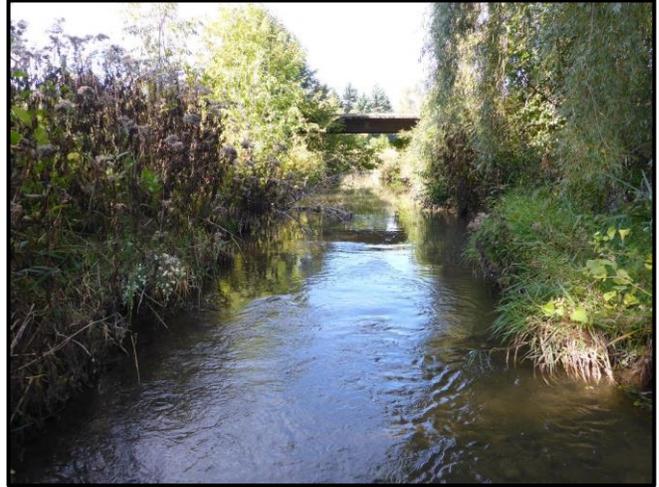
Photo 22
BR-3. Looking at upstream at golf cart path crossing.

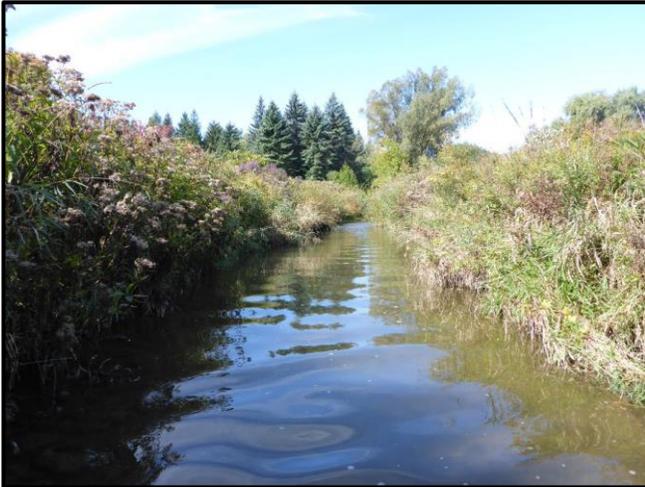
Photo 23
BR-4. Looking at upstream at general reach conditions. Note degree of entrenchment.

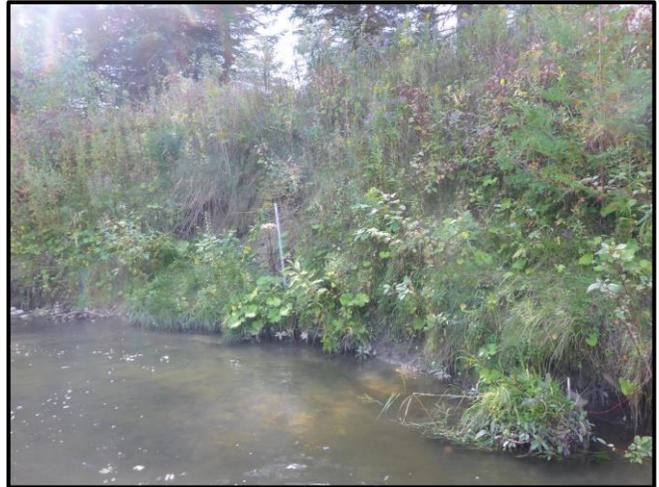
Photo 24
BR-4. Looking downstream erosion along right bank.

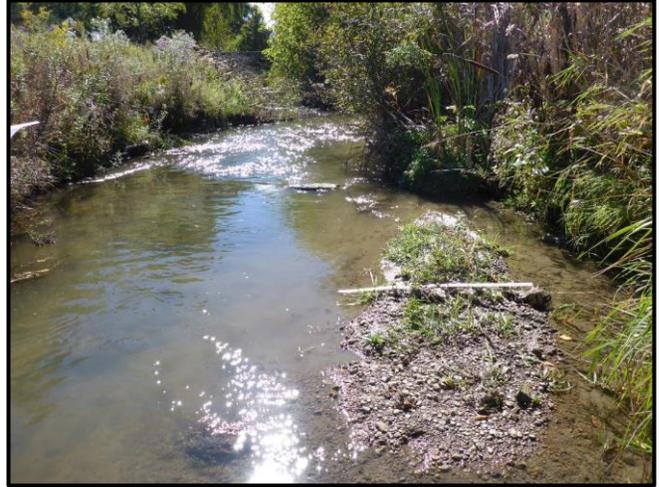
Photo 26
BR-4. Looking downstream at bar formation

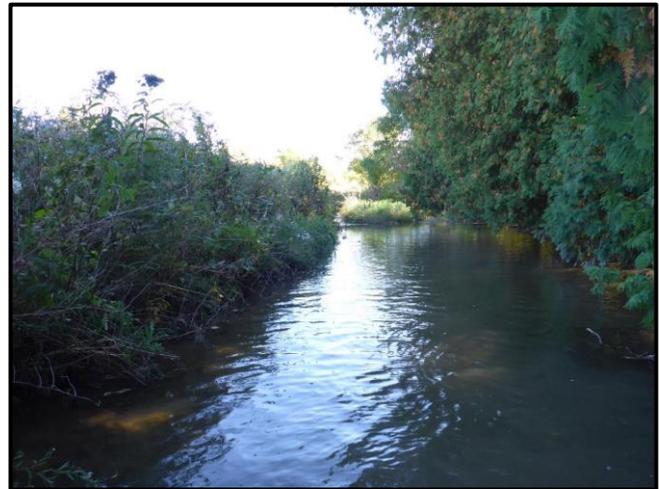
Photo 32 (Location 31)
BR-5. Looking downstream at general conditions. Note vegetated island within the channel and degree of entrenchment.

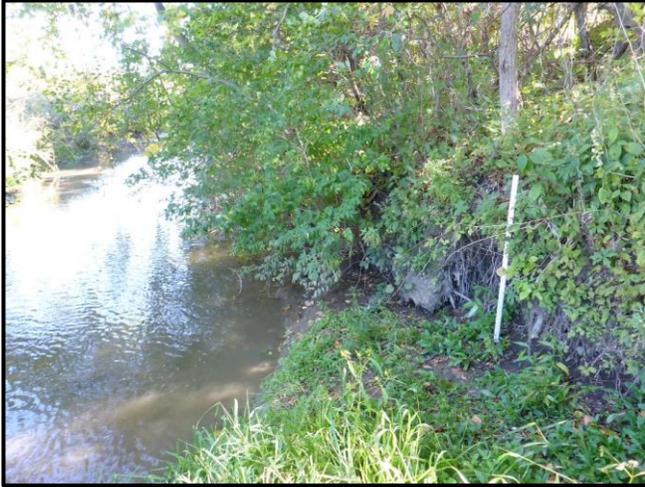
Photo 33 (Location 32)
BR-5. Looking downstream at erosion along right bank.

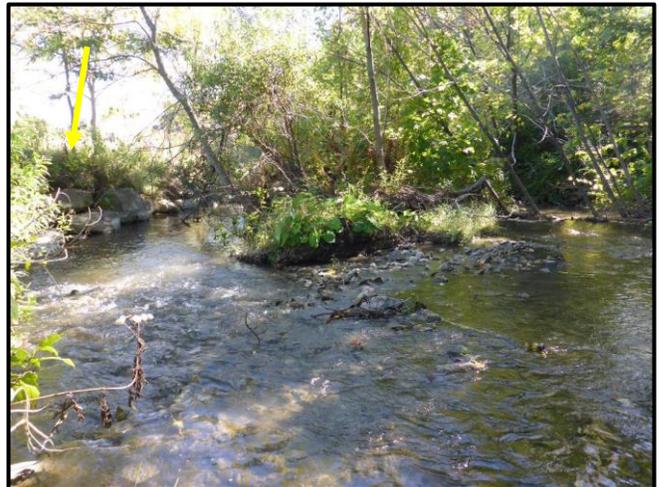
Photo 36 (Location 34)
BR-5. Looking downstream at island within the channel. Note the armoustone bank treatment along the left bank.

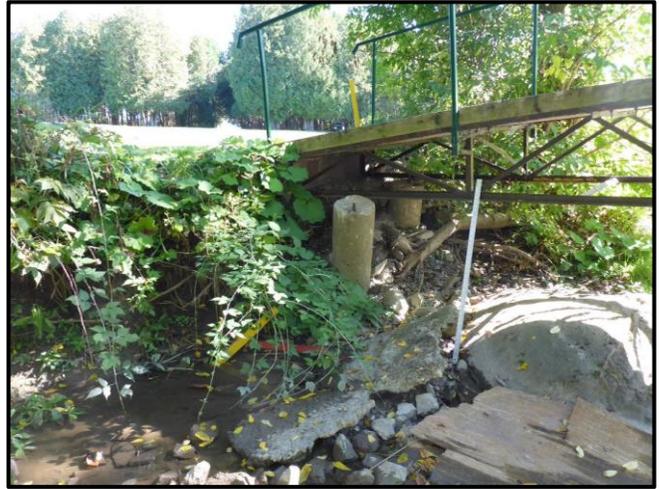
Photo 38 (Location 36)
BR-5. Exposed bridge footings of pedestrian crossing on right bank viewed downstream.

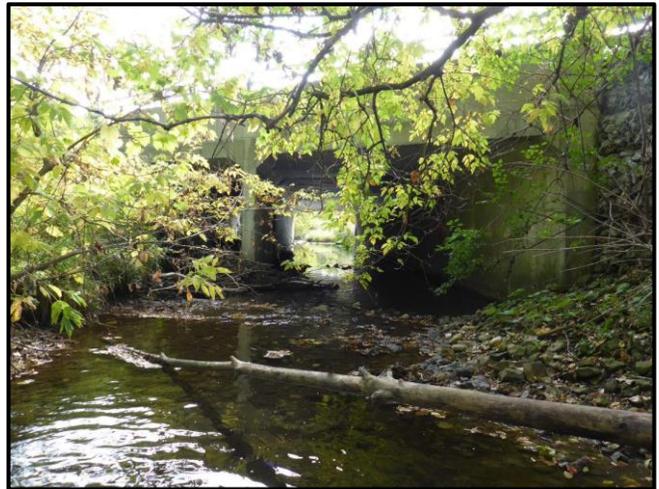
Photo 40 (Location 38)
BER-3. Looking downstream at 16th Avenue Road crossing.

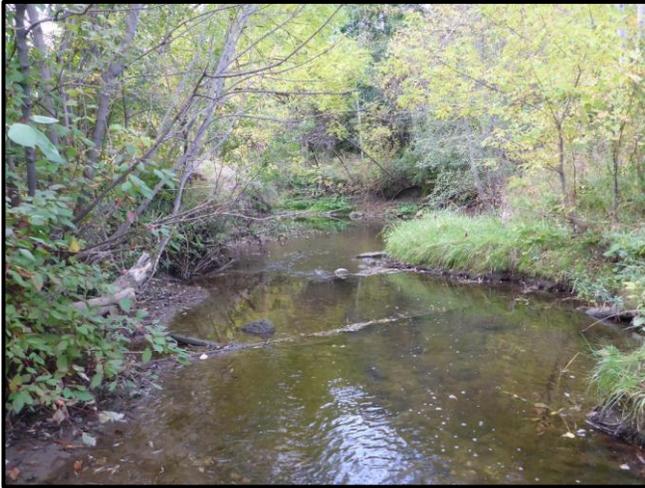
Photo 41 (Location 39)
BER-3. Looking downstream toward meander bend and general conditions.

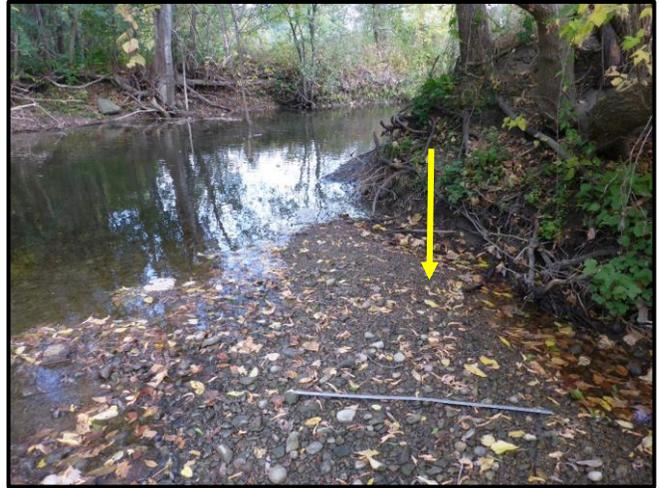
Photo 42 (Location 40)
BER-3. Looking upstream at meander bend. Note point bar formation on left bank (photo right) and scour on inside bend.

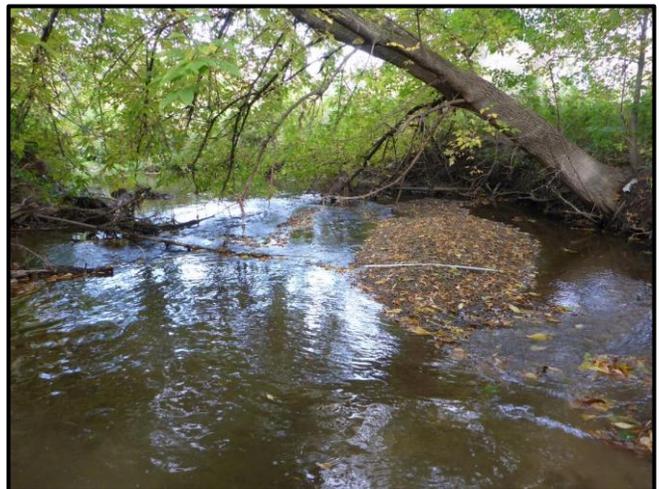
Photo 44 (Location 42)
BER-3. Looking downstream at leaning tree and lateral bar.

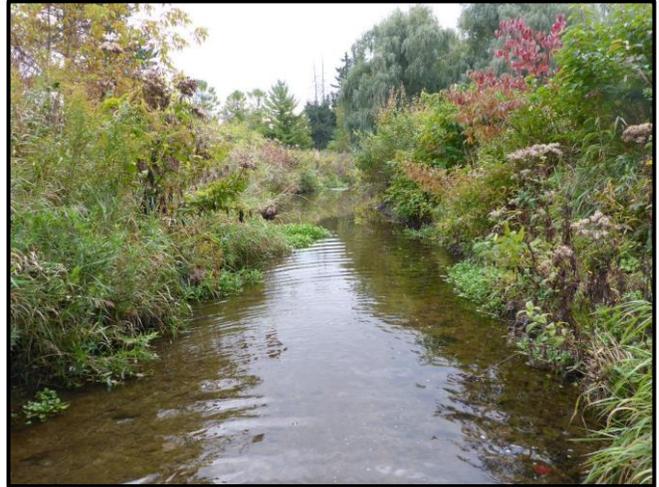
Photo 46 (Location 44)
BER-3. Looking downstream at general reach conditions. Note degree of entrenchment.

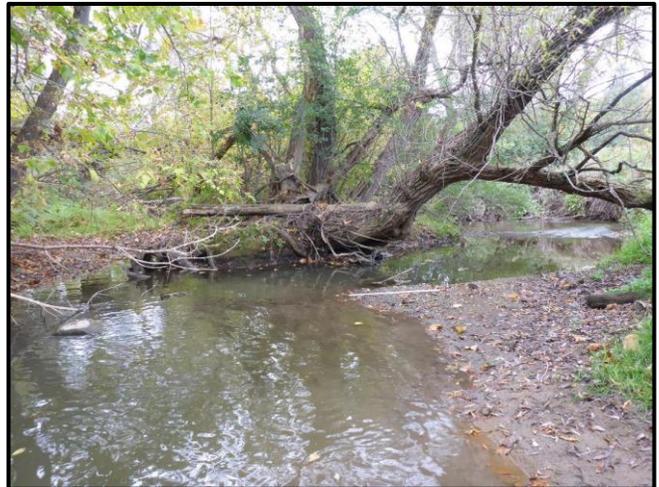
Photo 48 (Location 46)
BER-3. Looking downstream at leaning tree with exposed roots at sharp meander bend with a deep pool.

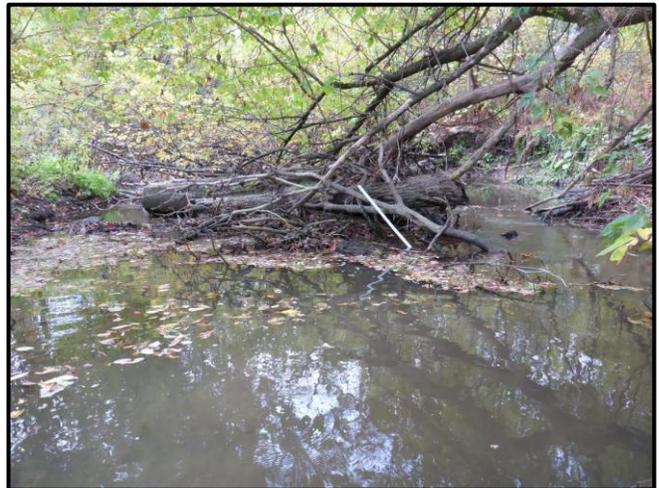
Photo 52 (Location 51)
BER-4. Looking downstream at large wood debris jam.

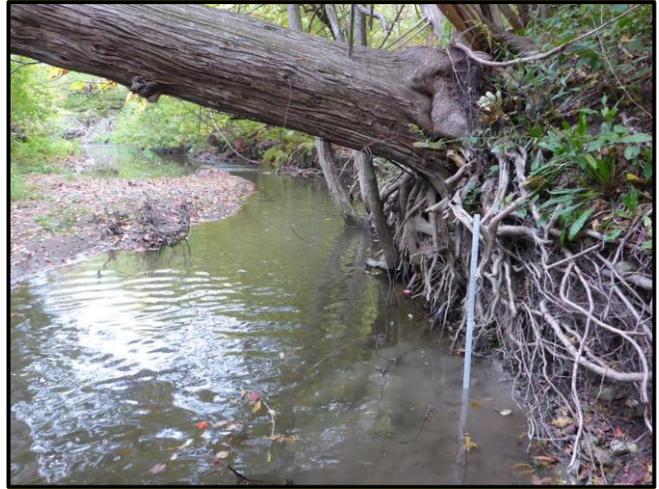
Photo 54 (Location 52)
BER-4. Looking upstream at leaning tree with exposed roots on the left bank.

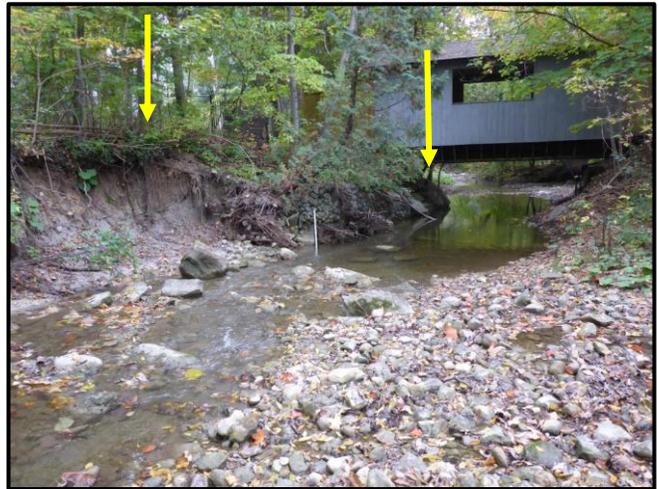
Photo 56 (Location 54)
BER-6. Looking downstream at a bridge crossing at the downstream extent assessed. Note the large deep scour pool and failing footings under the bridge and the erosion on right bank (photo left).

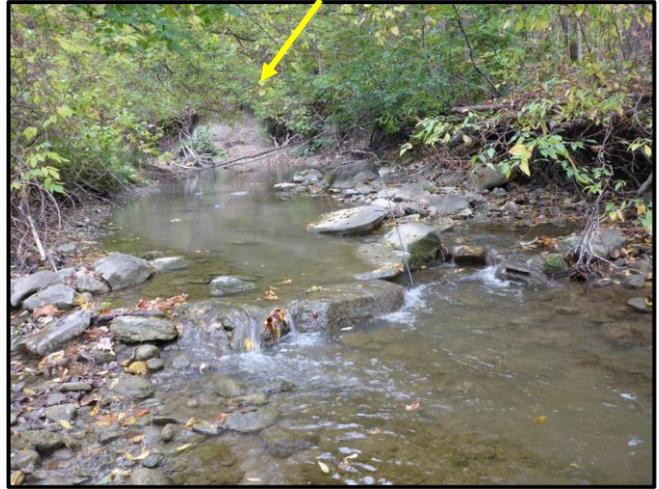
Photo 58 (Location 56)
BER-6. Looking upstream at boulder step-pool. Note outer bank erosion on meander bend in background.

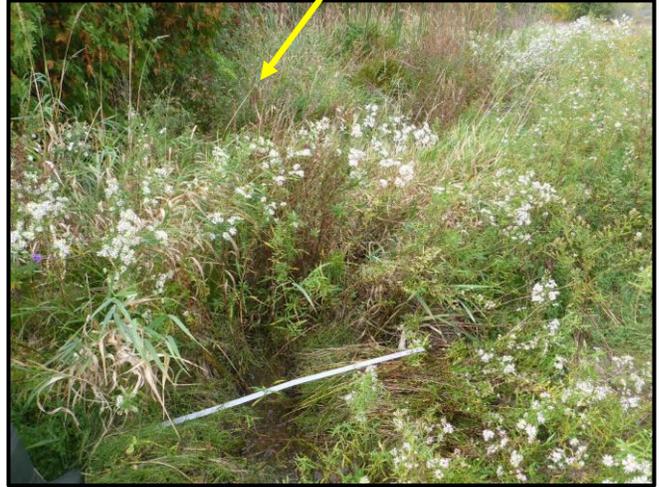
Surface Flow - Photo 62 (Location 60)
Downstream view of surface drainage feature.
Note density of riparian vegetation and poorly defined nature of feature.

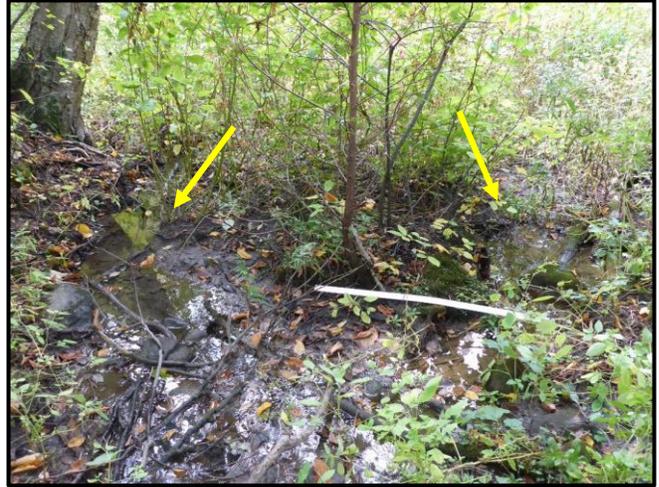
Surface Flow - Photo 66 (Location 64)
Downstream view of surface drainage feature.
Note: poorly defined nature of feature and multiple surface flow paths.

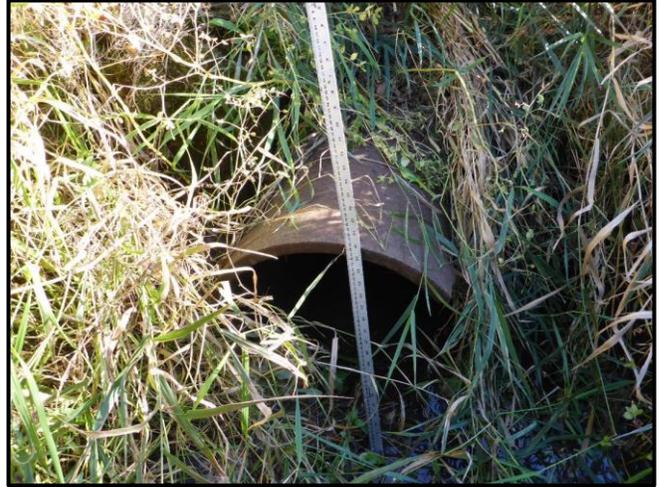
Surface Flow - Photo 70 (Location 68)
Existing pipe outlet.

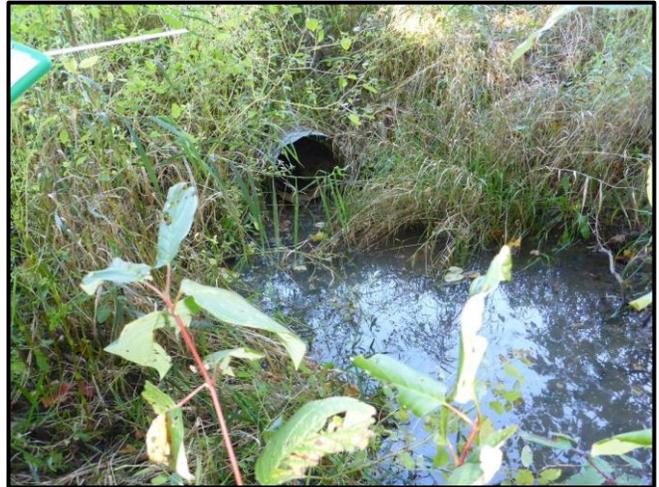
Surface Flow - Photo 72 (Location 70)
Downstream view of pipe inlet.

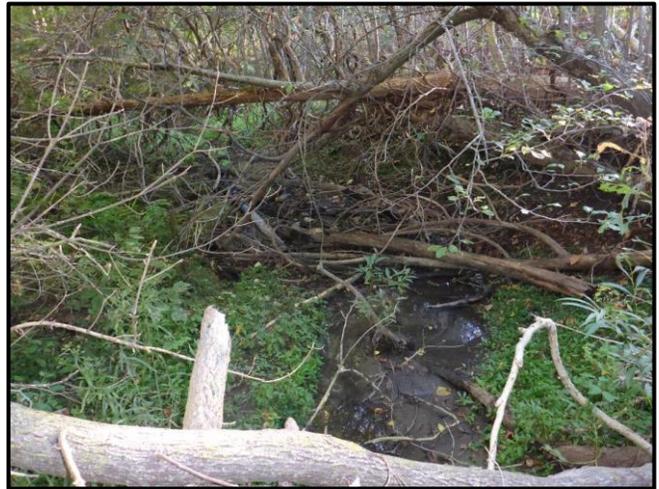
Surface Flow - Photo 76 (Location 74)
Upstream view of surface drainage feature. Note:
presence of woody debris and poorly defined
nature of feature.

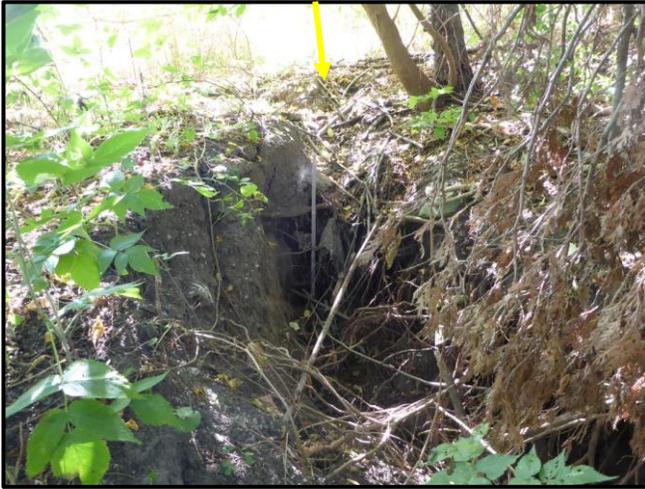
Surface Flow - Photo 85 (Location 82)
Upstream view of existing gully feature observed along valley slope.

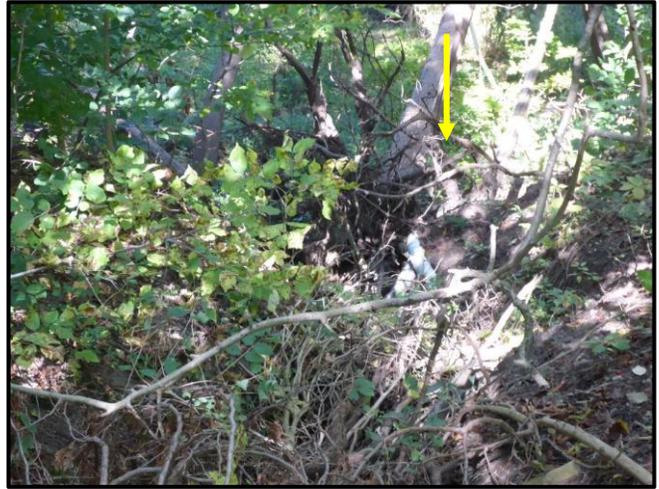
Surface Flow - Photo 86 (Location 82)
Downstream view of gully feature and tile drain outlet to Bruce Creek.
