Fluvial Geomorphology Report

in support of a
Master Environmental Servicing Plan
4134 16th Avenue, City of Markham

Sixteenth Land Holdings Inc.

November 2017 215200.1

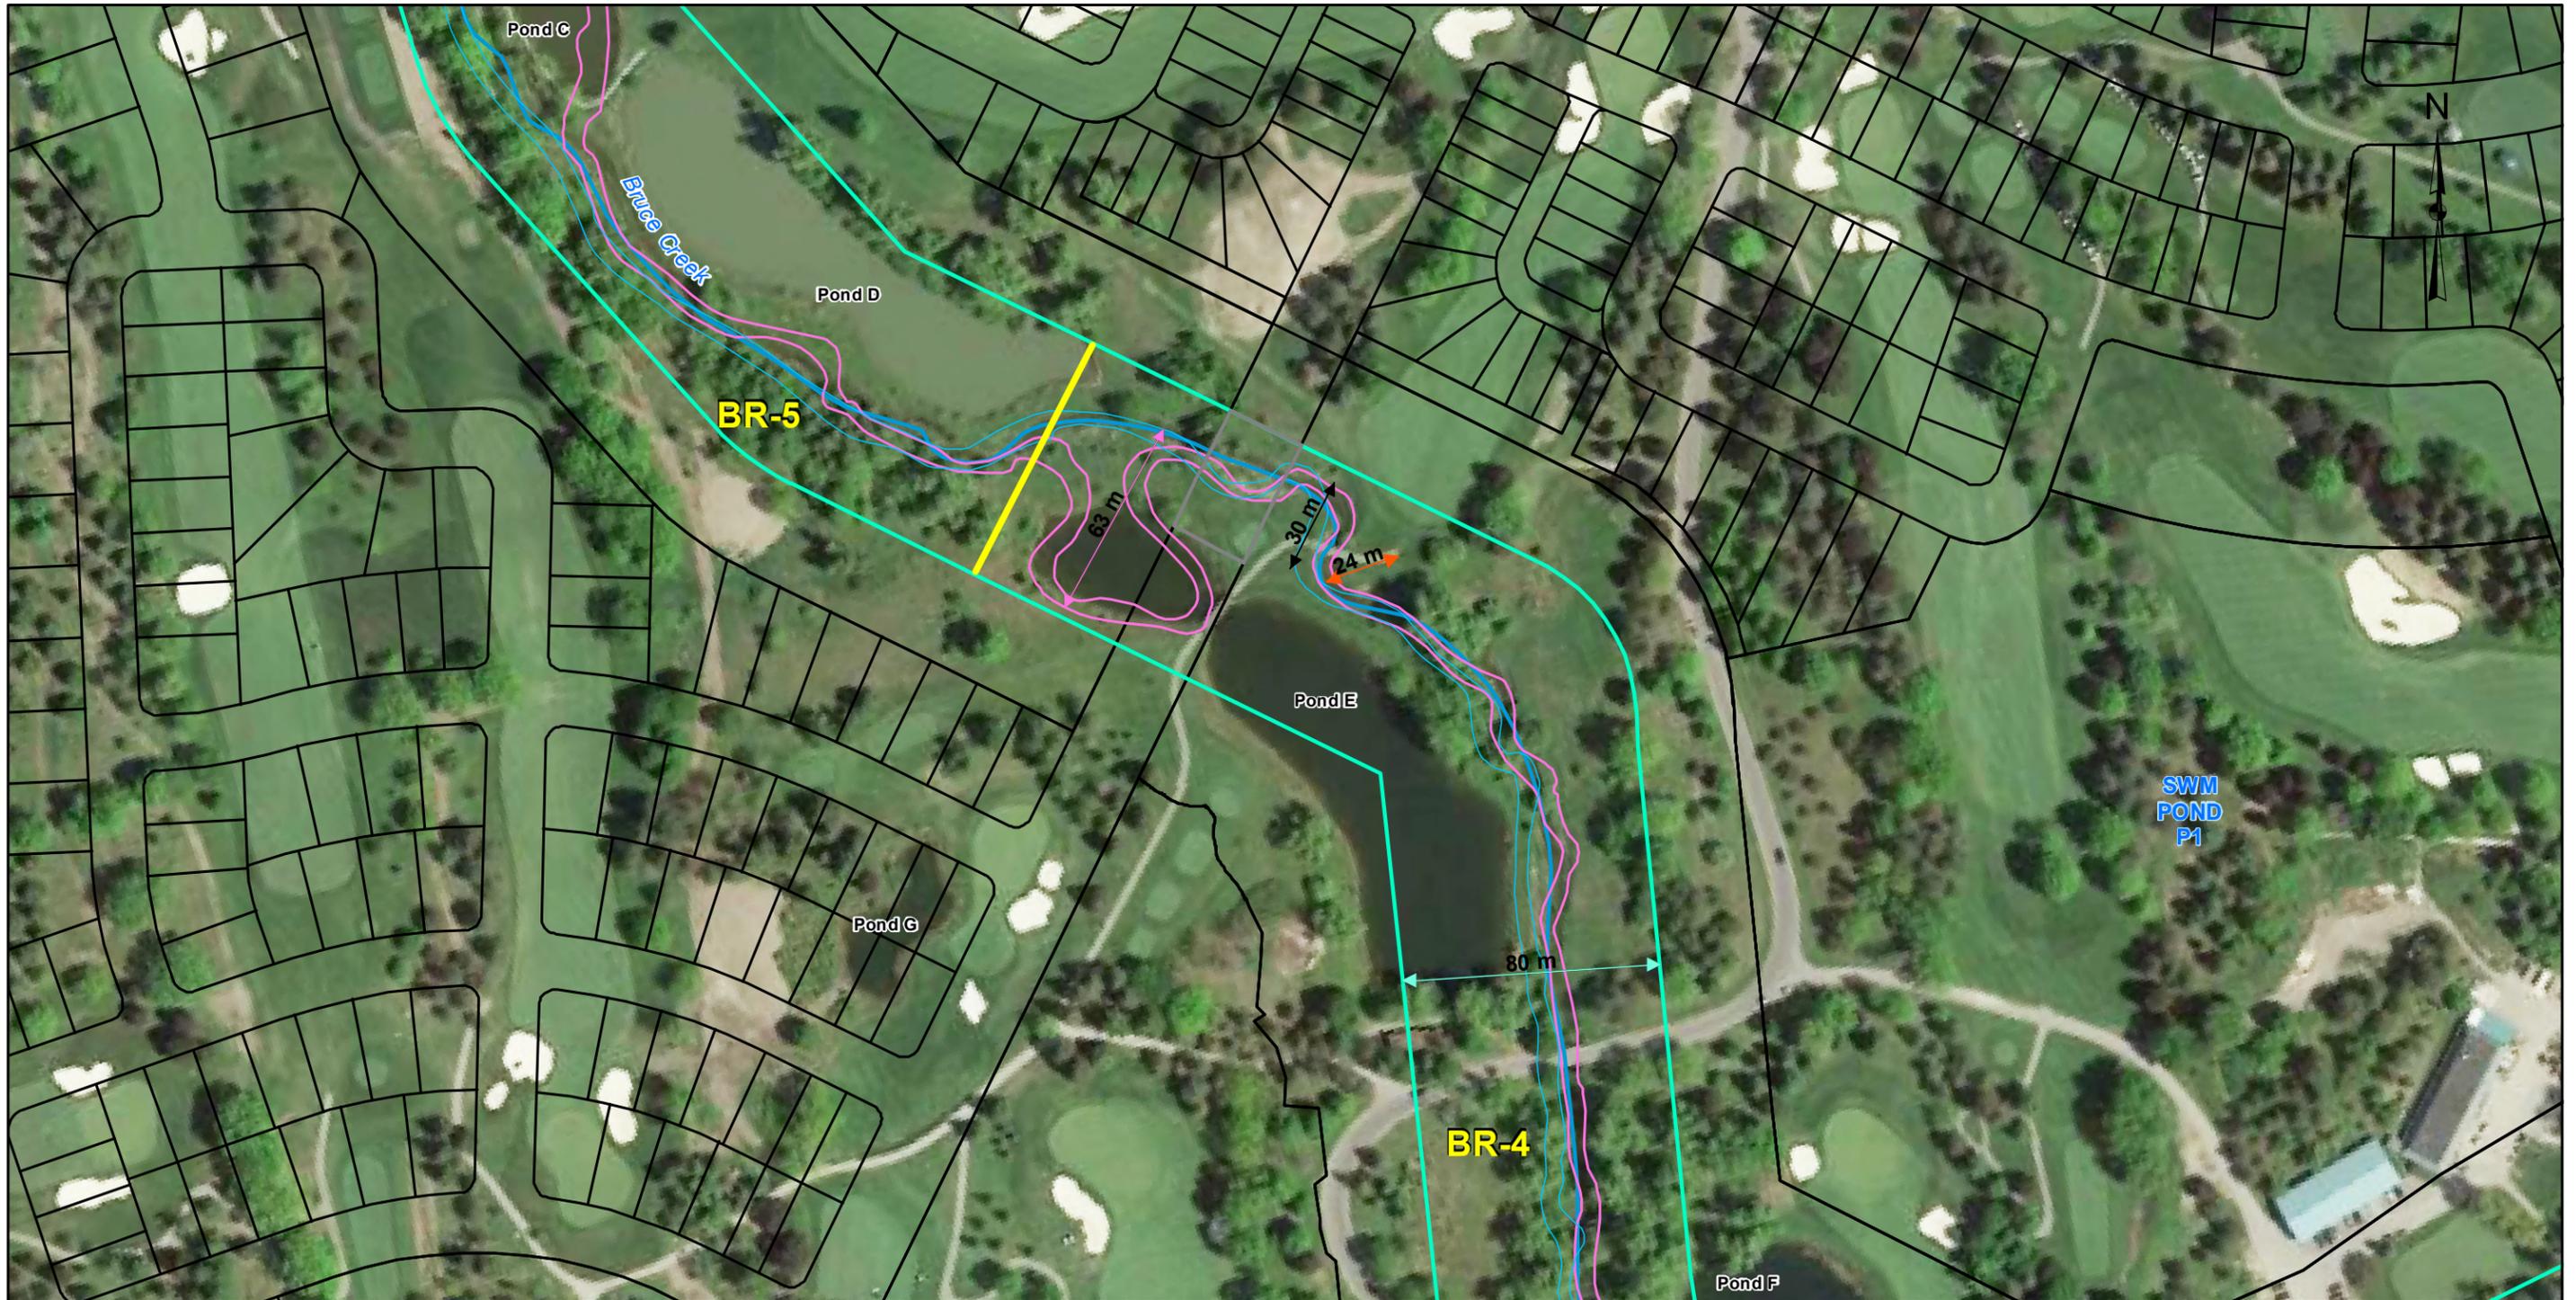
FIGURE 6: Road Crossing Analysis

At 40 m, the proposed span is sufficient to accommodate the field-based meander amplitude, as well as the governing amplitude measured in the vicinity of the crossing based on the proposed road alignment. That stated, these governing meander amplitudes were measured downstream of the revised road crossing location. As the general trend in channel migration between 1974 and 2016 (post-channelization) is in the down-valley direction (refer to **Figure 6**), it is not anticipated that future migration of this meander bend would pose a risk to the structure. Further, the crossing structure has been centred on a straight section of the creek and provides a lateral offset of approximately 15 m on either side of the active (bankfull) channel. As data from the 42 year historic record indicates minimal lateral channel migration the proposed 40 m crossing span was deemed appropriate to accommodate long-term adjustments in channel form and meander geometry.

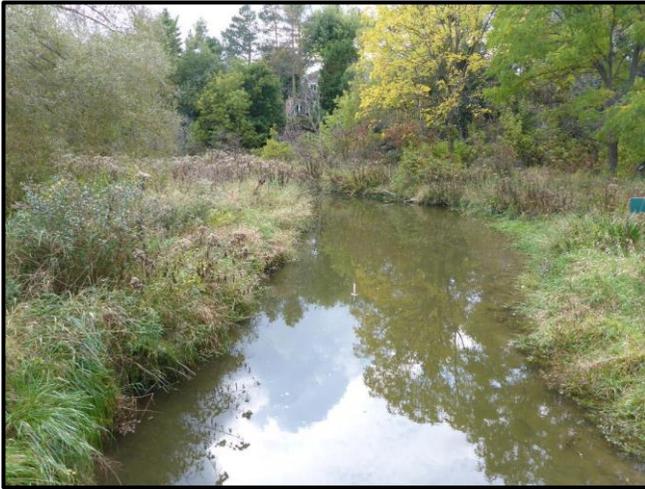
Photo 1

BR-1. Downstream view from pedestrian trail bridge at upstream reach extent. Note widened channel due to backwater from downstream Toogood Pond.

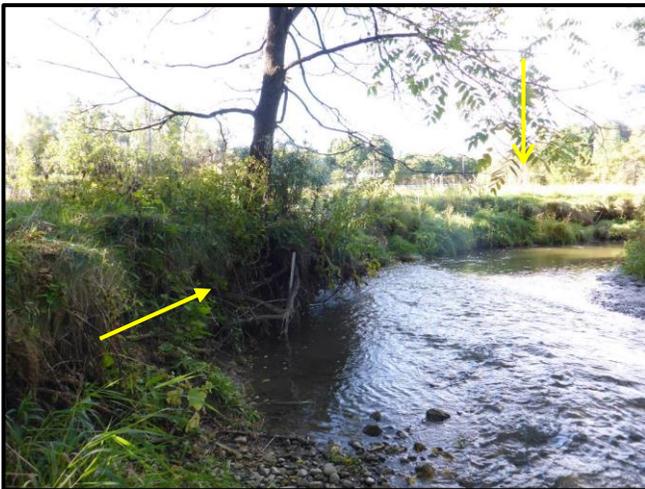
Photo 7
BR-2. Exposed tree roots and slumping banks at outside meander bend viewed downstream.

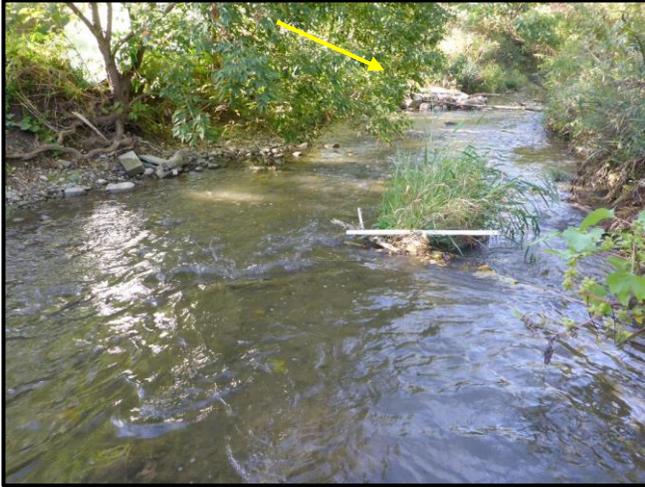
Photo 9
BR-2. Vegetated bar viewed downstream. Note also old bridge footing remains within channel.

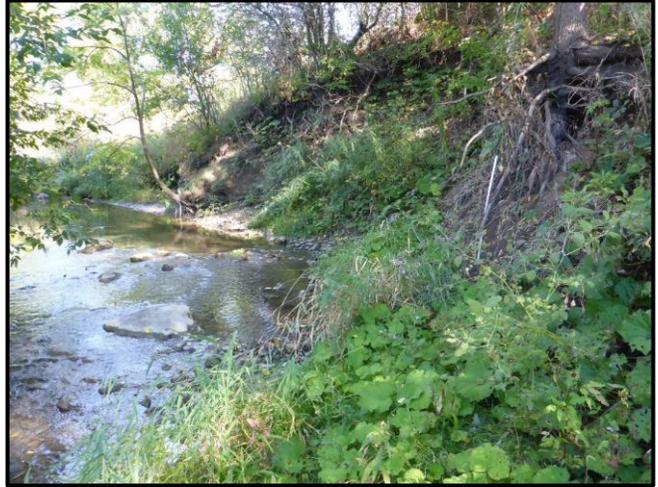
Photo 10
BR-2. Valley wall contact on left bank (photo right) viewed upstream.

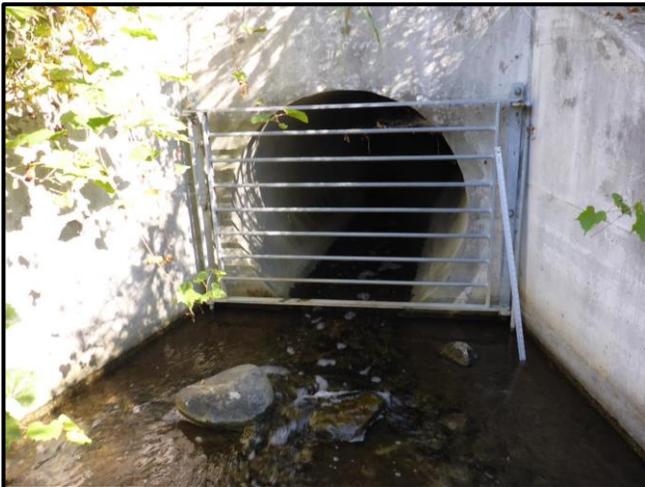
Photo 11
BR-2. 1250 mm storm outfall on left bank.

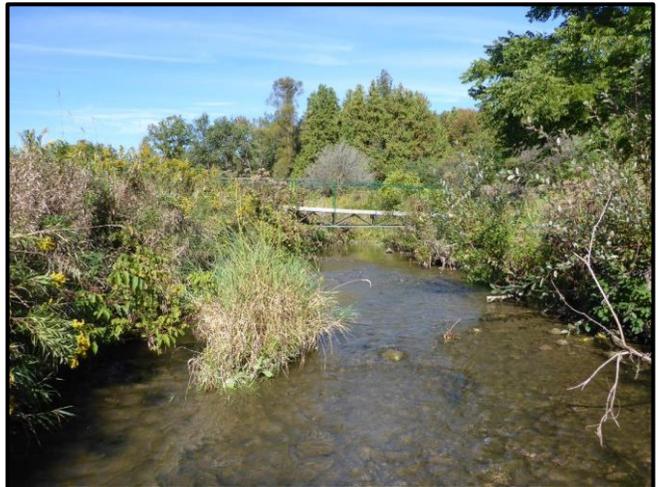
Photo 12
BR-2. Looking upstream at pedestrian crossing. Note vegetated bar within the channel.

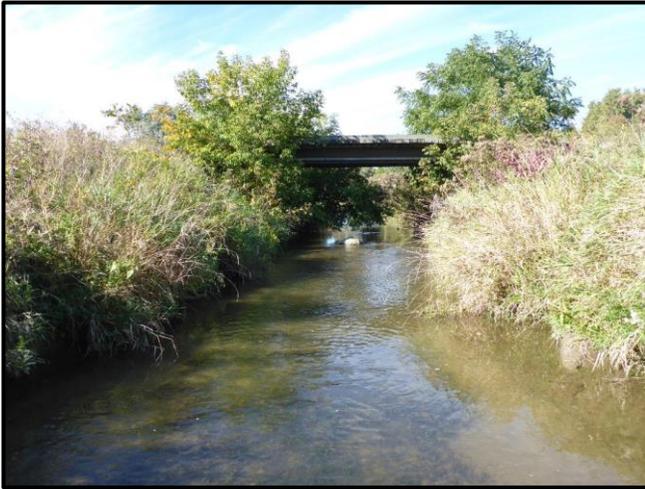
Photo 13
BR-2. Looking upstream toward golf cart path crossing.

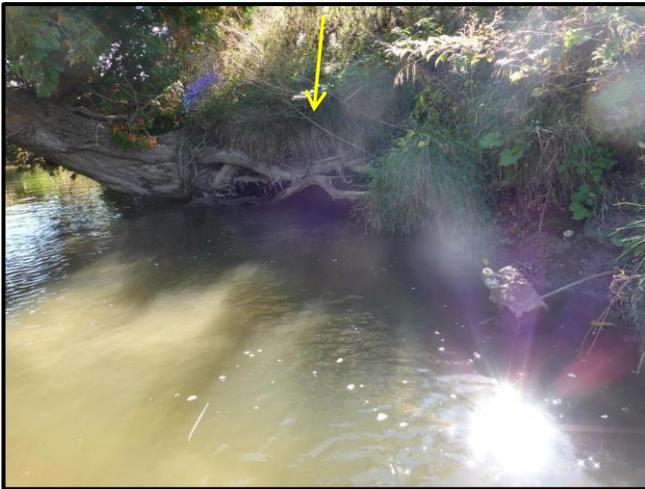
Photo 15
BR-3. Looking downstream at exposed tree roots and under right bank.

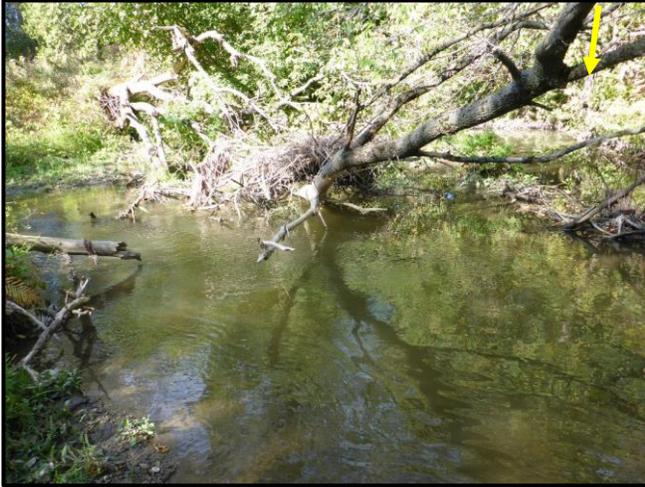
Photo 17
BR-3. Looking upstream at debris jam creating backwater area. Note confluence with surface flow feature into backwater area.

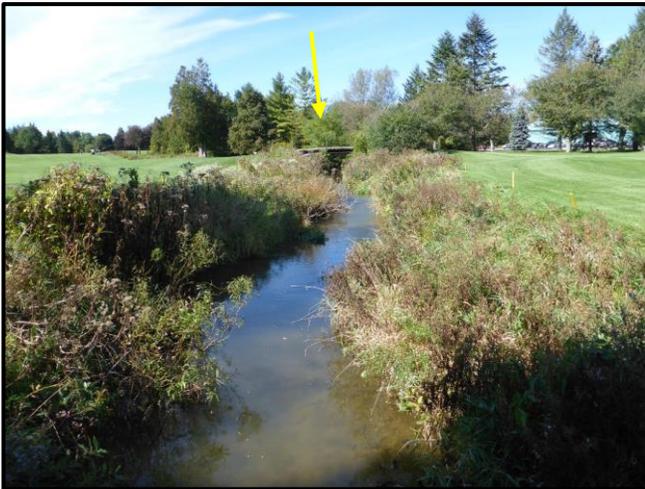
Photo 19
BR-3. Looking upstream from pedestrian crossing at golf cart path crossing. Note manicured grass riparian vegetation.

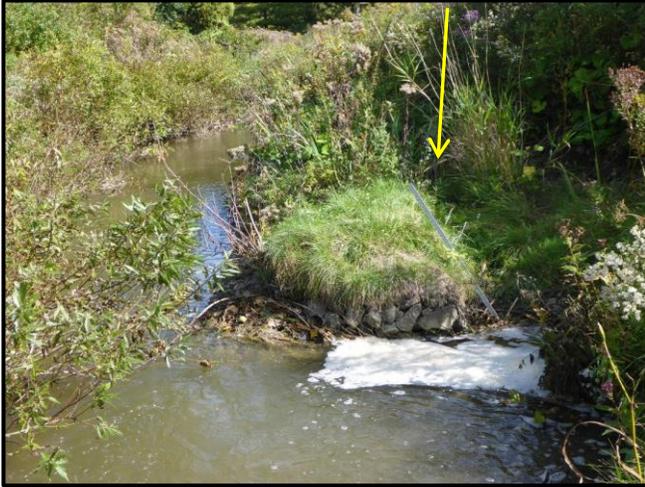
Photo 21
BR-3. Looking downstream at outflanked and undermined gabion basket on right bank.

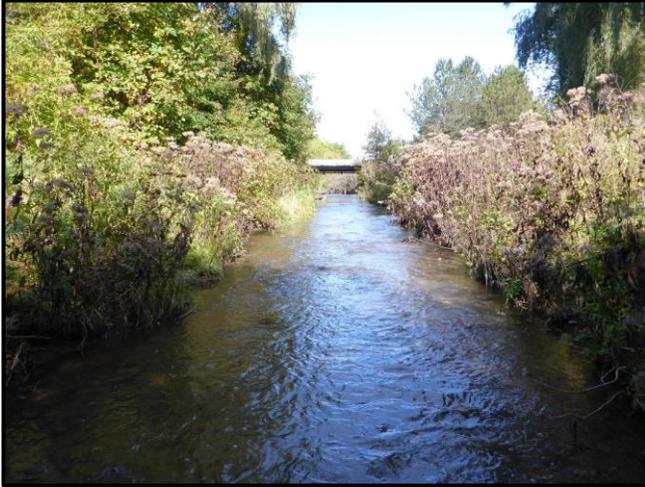
Photo 25
BR-4. Looking upstream at driveway crossing.

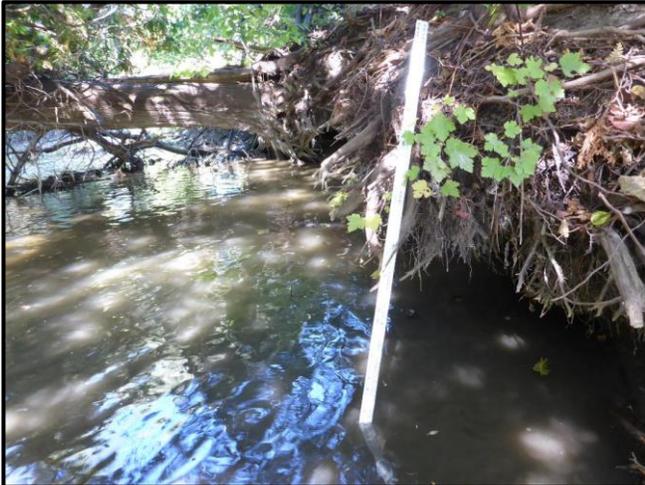
Photo 27
BR-4. Looking downstream at fallen cedar tree, exposed roots and undercut bank.

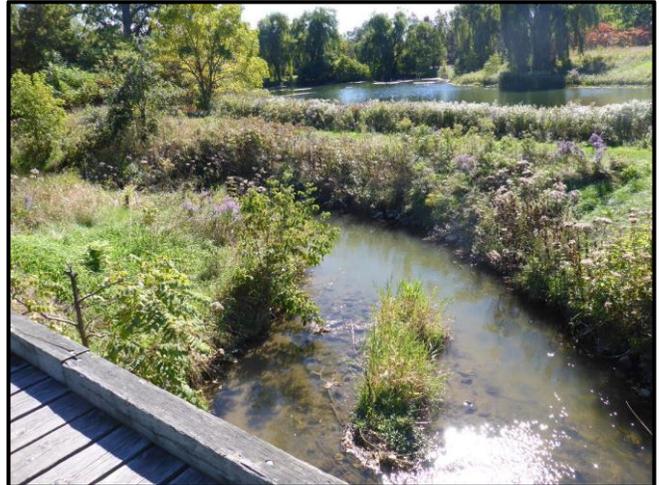
Photo 28 (Location 28)
BR-4. Looking downstream from golf cart path crossing. Note proximity to online pond.

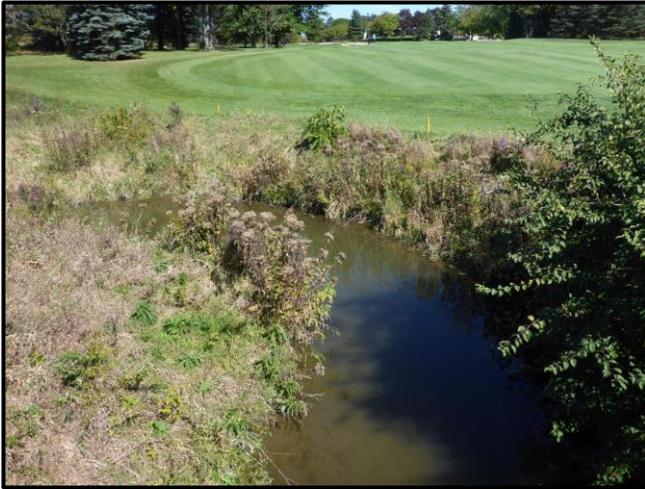
Photo 29 (Location 28)
BR-4. Looking upstream from golf cart path crossing at meander bend. Note manicure grass riparian vegetation.

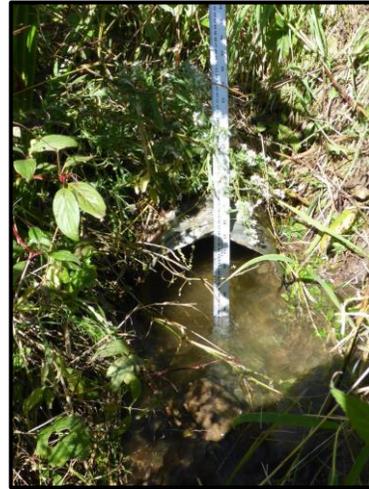
Photo 30 (Location 29)
BR-4. Pond outlet to creek.

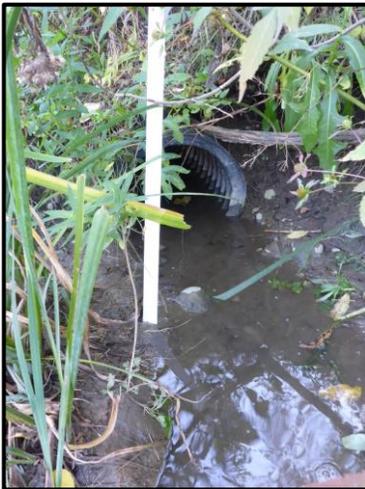
Photo 31 (Location 30)
BR-5. Tile drain outlet on right bank.

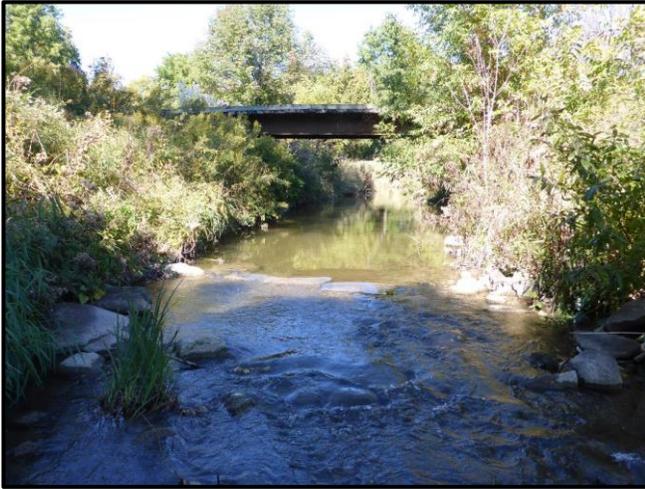
Photo 37 (Location 35)
BR-5. Looking upstream at golf cart path crossing.
Note riffle substrate size.

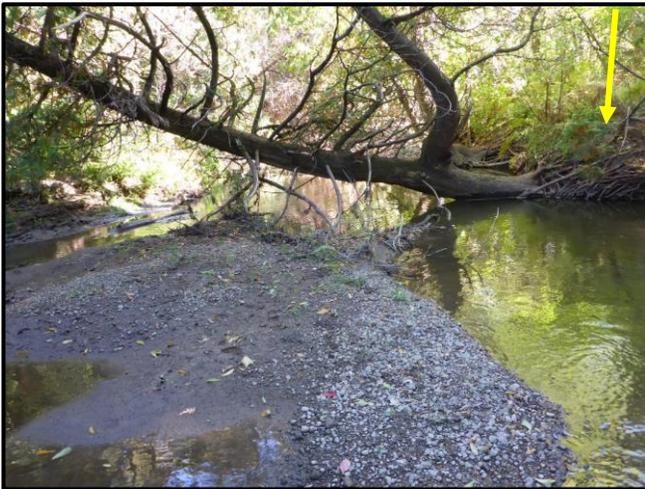
Photo 39 (Location 37)
BR-5. Looking downstream of fallen cedar tree and bar formation. Note the confluence with surface flow feature.

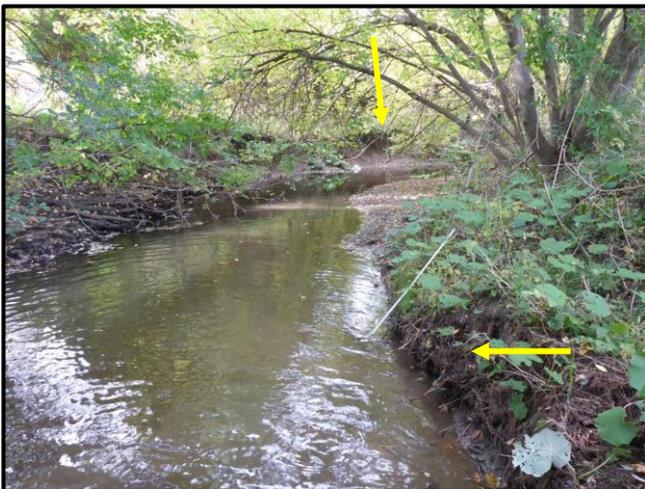
Photo 43 (Location 41)
BER-3. Looking downstream at sharp meander bend. Note erosion on outside of bend, point bar formation on inside of bend and basal scour on both sides.

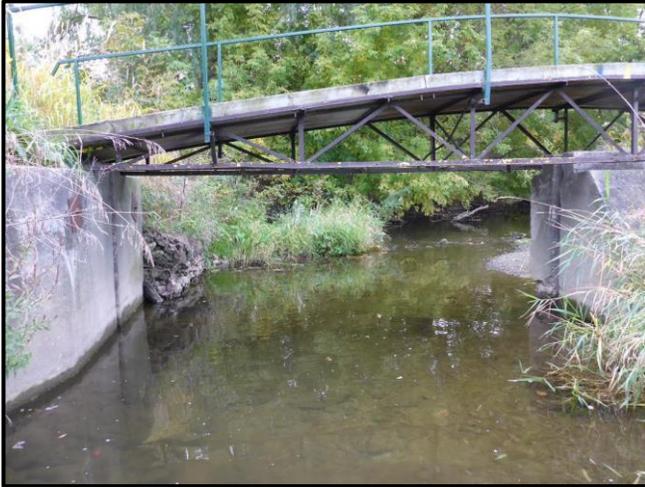
Photo 45 (Location 43)
BER-3. Looking downstream at pedestrian crossing.

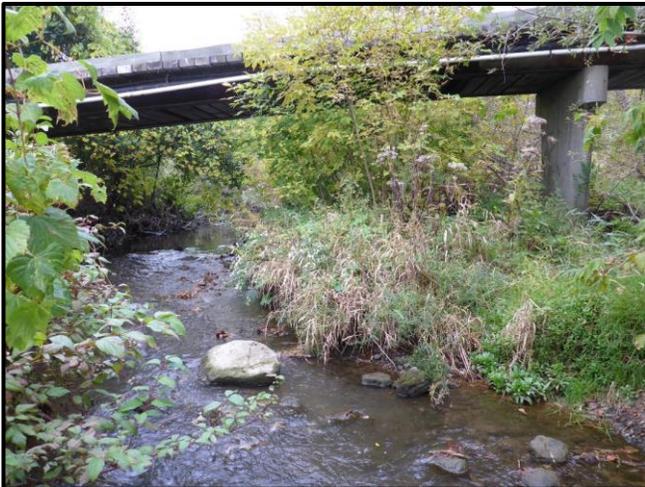
Photo 47 (Location 45)
BER-3. Looking downstream at golf cart path crossing.

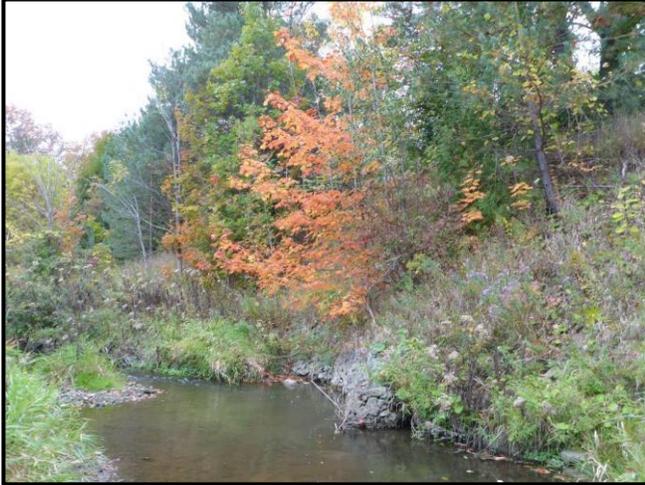
Photo 49 (Location 47)
BER-3. Looking upstream at valley wall contact and outflanked gabion basket bank protection on left bank (photo right).

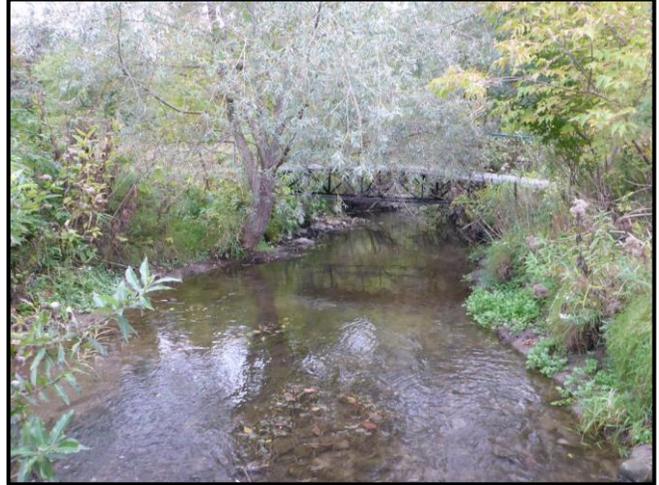
Photo 50 (Location 48)
BER-3. Looking downstream at pedestrian crossing.

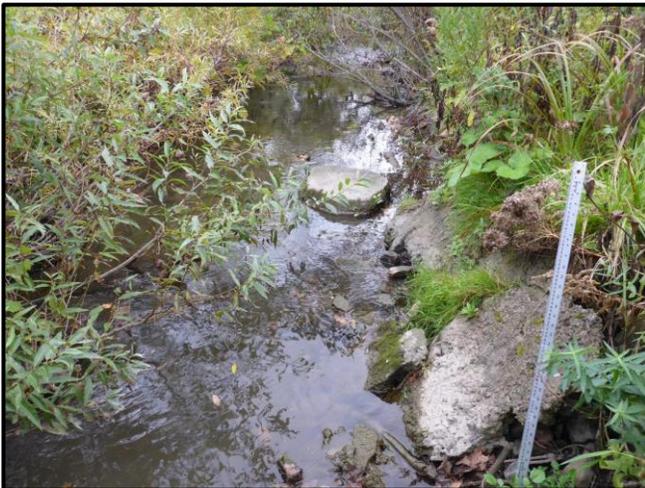
Photo 51 (Location 50)
BER-3. Looking downstream at ad-hoc bank protection on right bank.

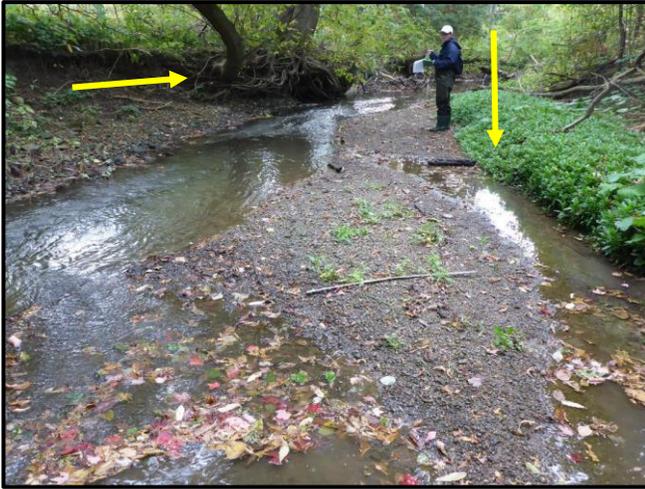
Photo 53 (Location 51)
BER-4. Looking downstream at riffle within a meander bend. Note point bar with cut face and exposed tree roots.

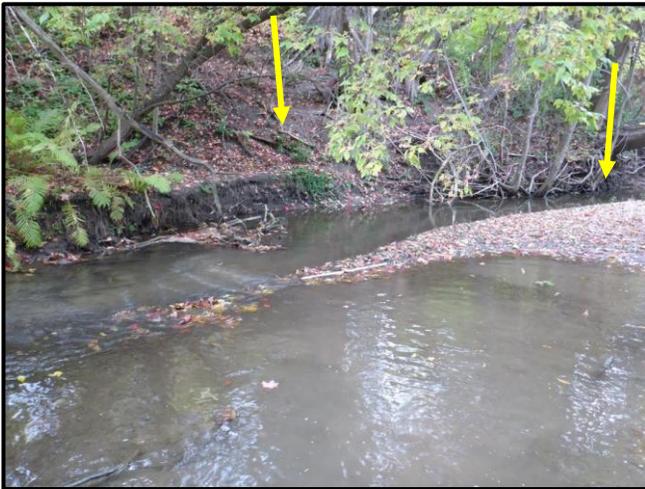
Photo 55 (Location 53)
BER-4. Looking downstream at lateral bar and valley wall contact on left bank. Note also misalignment of thalweg.

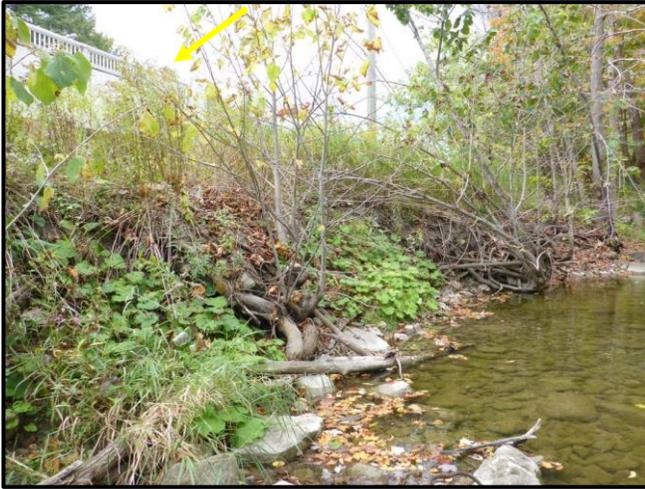
Photo 57 (Location 55)
BER-6. Looking upstream at meander bend against Warden Avenue bridge.

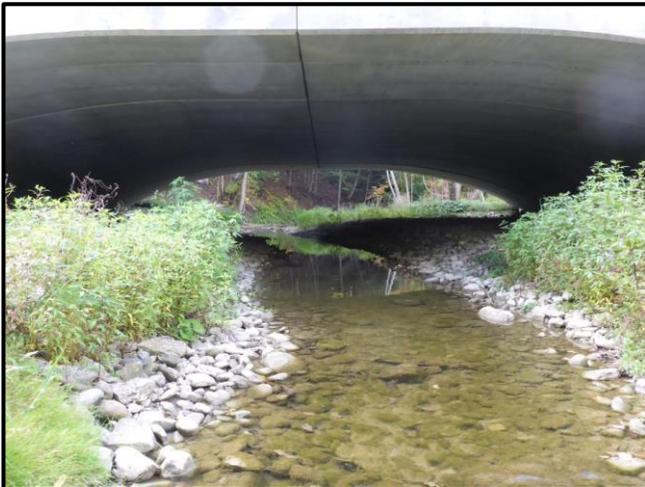
Photo 59 (Location 57)
BER-6. Looking upstream at Warden Avenue crossing.

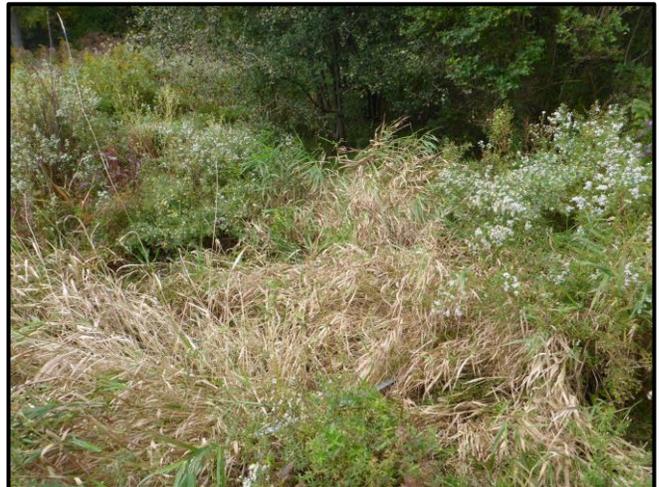
Surface Flow - Photo 60 (Location 58)
General riparian conditions along surface drainage feature.

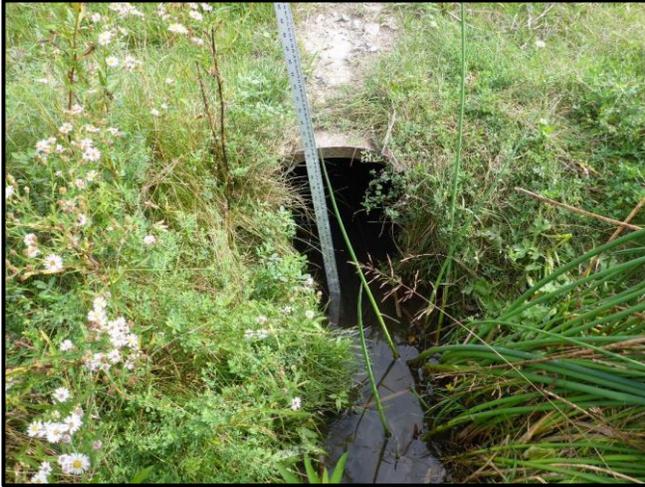
Surface Flow - Photo 61 (Location 59)
Existing 500 mm culvert under laneway crossing.

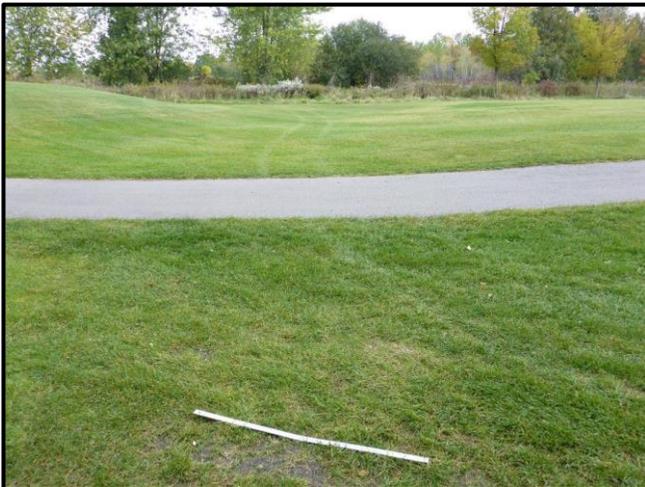
Surface Flow - Photo 63 (Location 61)
Downstream view of potential overland conveyance area across the existing fairway.
Surface drainage feature is piped.

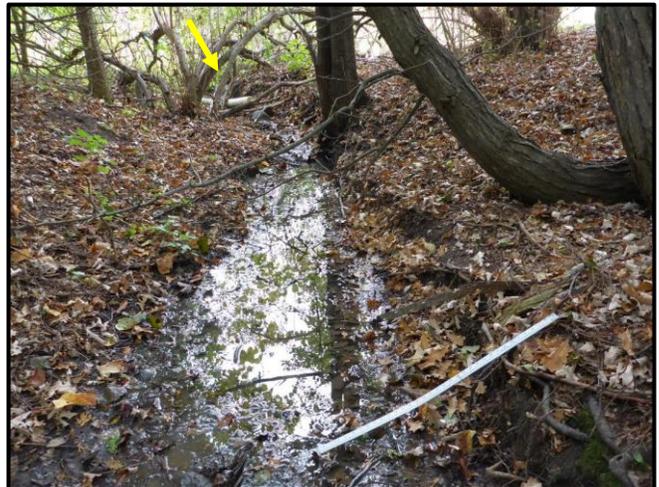
Surface Flow - Photo 64 (Location 62)
Upstream view of surface drainage feature and tile drain outlet.

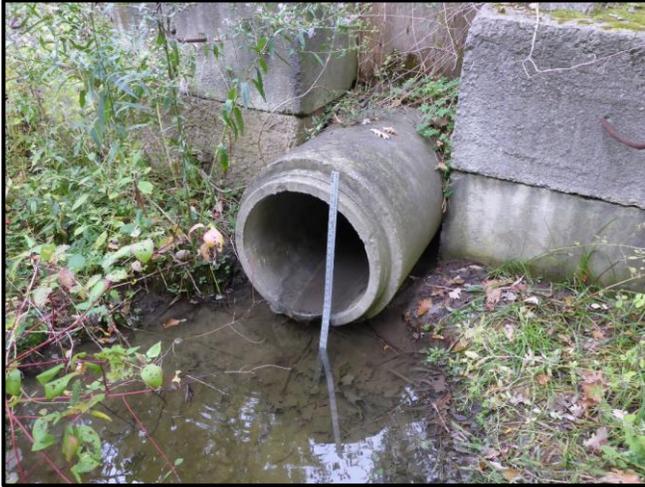
Surface Flow - Photo 65 (Location 63)
Upstream view of culvert under existing golf cart path.

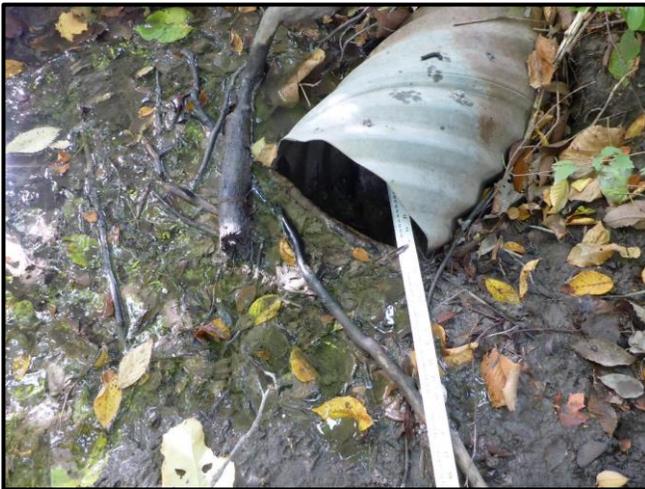
Surface Flow - Photo 67 (Location 65)
Existing 300 mm CSP culvert.

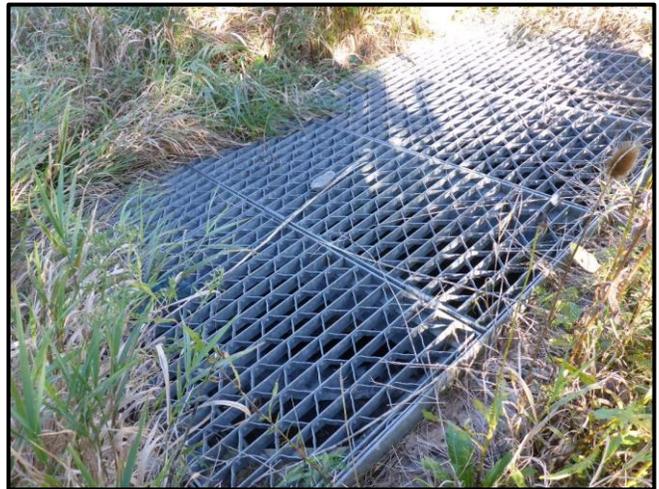
Surface Flow - Photo 68 (Location 66)
Existing catch basin associated with Pond H.

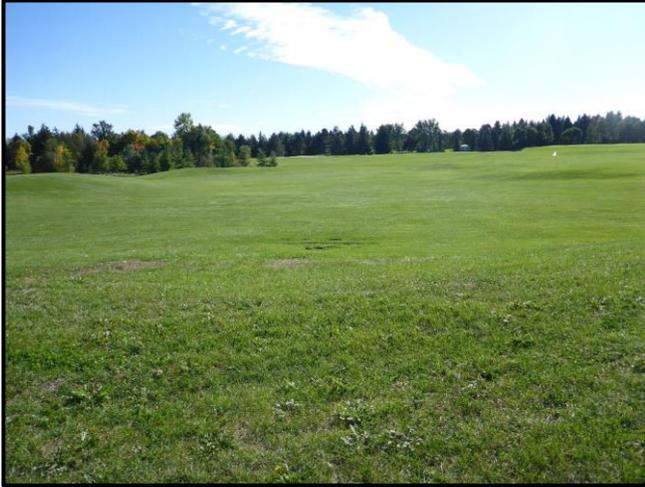
Surface Flow - Photo 69 (Location 67)
South-facing view of surface conveyance area associated with Pond H along the existing golf course driving range.

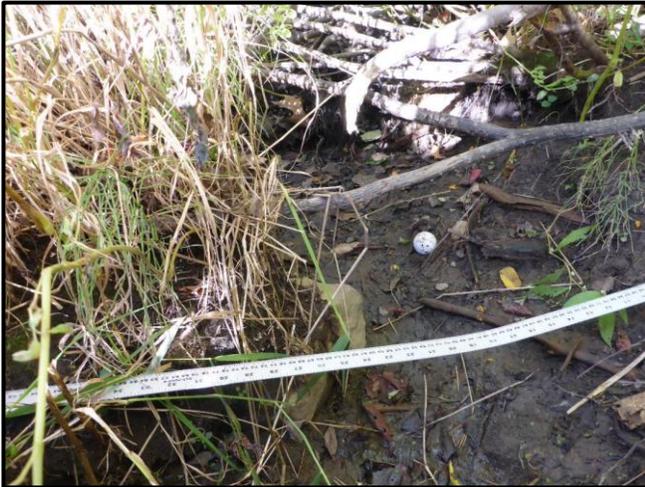
Surface Flow - Photo 71 (Location 69)
Upstream view of surface drainage feature. Note: feature was poorly defined.

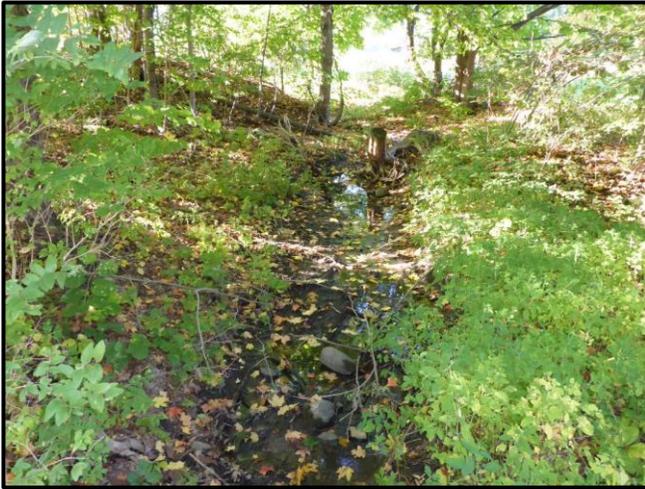
Surface Flow - Photo 73 (Location 71)
Downstream view of surface drainage feature.

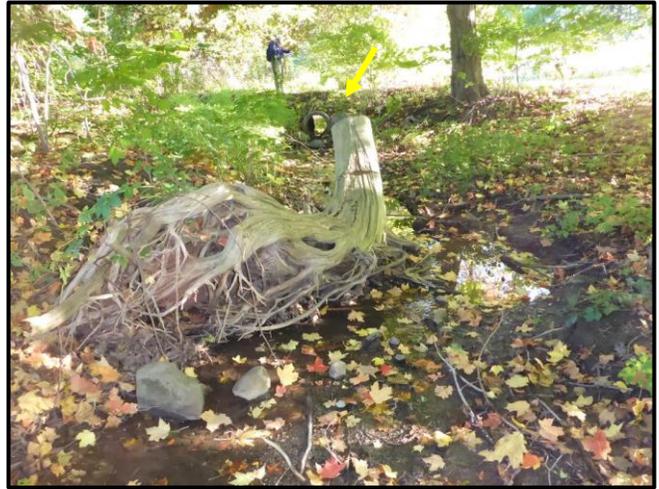
Surface Flow - Photo 74 (Location 72)
Upstream view of surface drainage feature and existing laneway crossing.

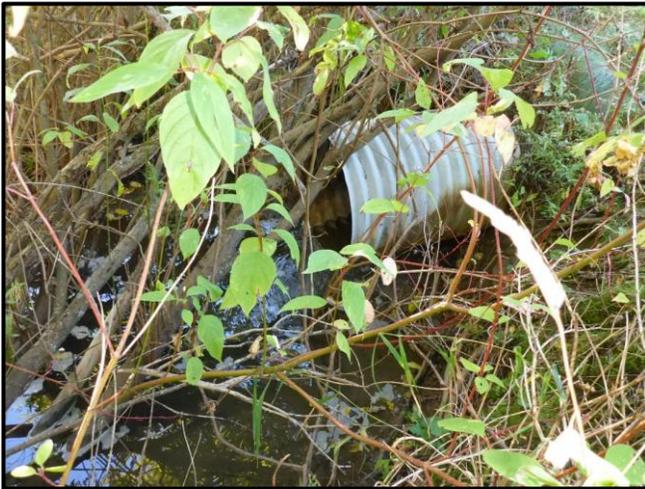
Surface Flow - Photo 75 (Location 73)
Upstream view of pipe outlet.

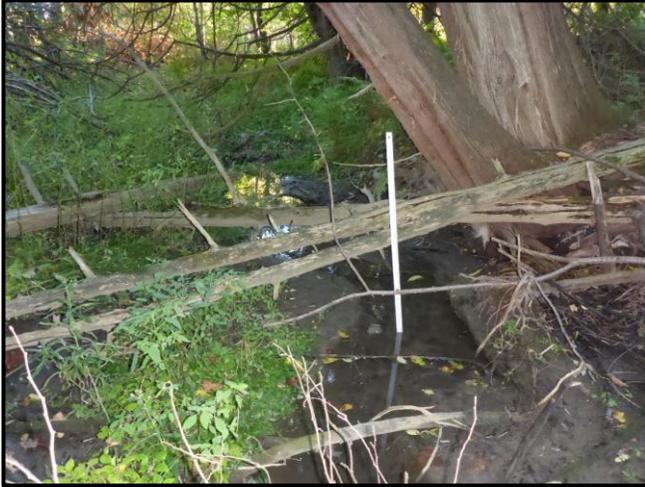
Surface Flow - Photo 77 (Location 75)
Downstream view of surface drainage feature.

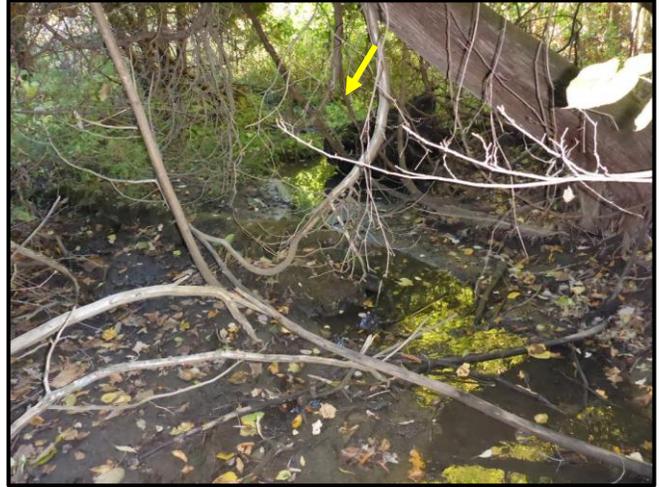
Surface Flow - Photo 78 (Location 76)
Upstream view of surface drainage feature.

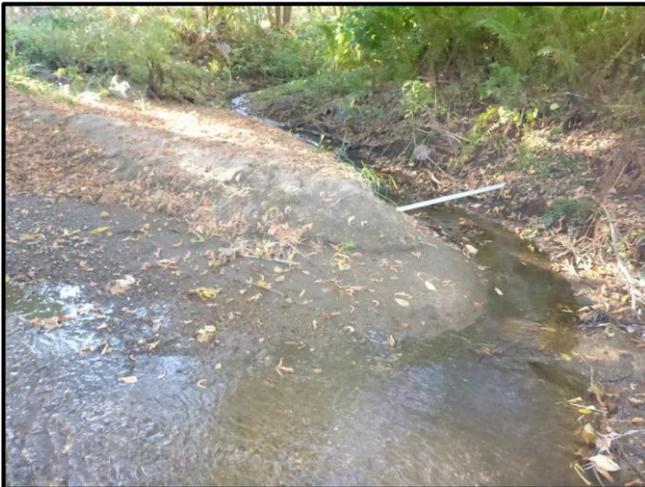
Surface Flow - Photo 79 (Location 77)
Upstream view of surface drainage feature
confluence with Bruce Creek (Reach BR-3).

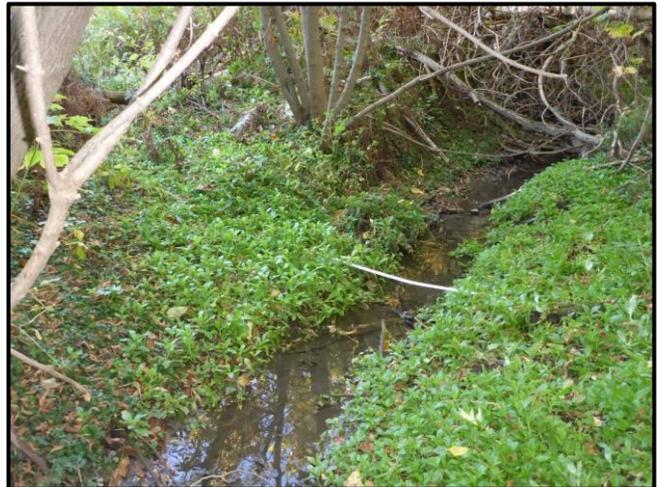
Surface Flow - Photo 80 (Location 78)
Downstream view of surface drainage feature.

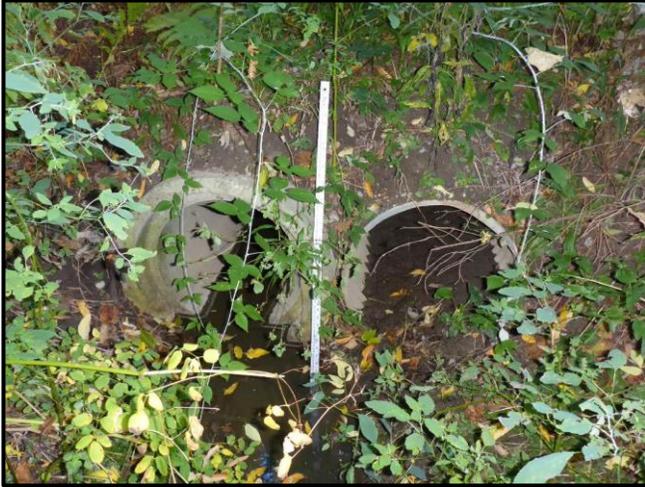
Surface Flow - Photo 81 (Location 79)
Upstream view of existing twin culvert under laneway crossing of surface drainage feature.

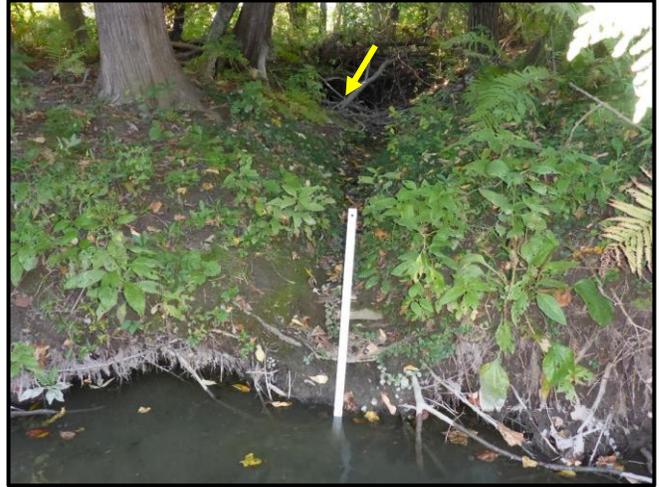
Surface Flow - Photo 82 (Location 80)
Upstream view of surface drainage feature confluence with Bruce Creek (Reach BR-3). Note 0.4 m drop to creek bed.

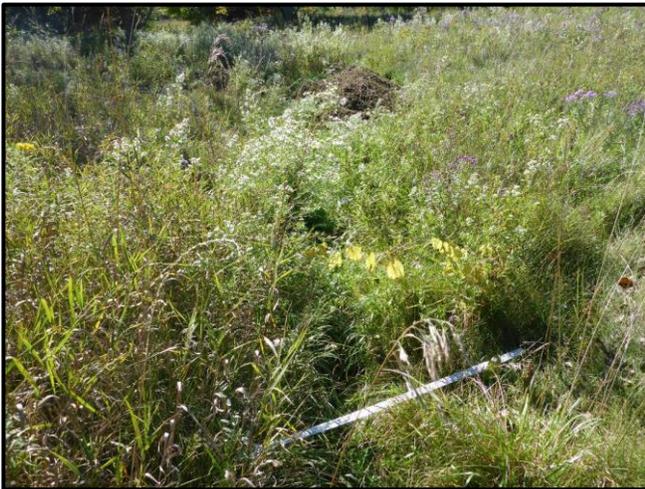
Surface Flow - Photo 83 (Location 81)
Upstream view of surface drainage feature.

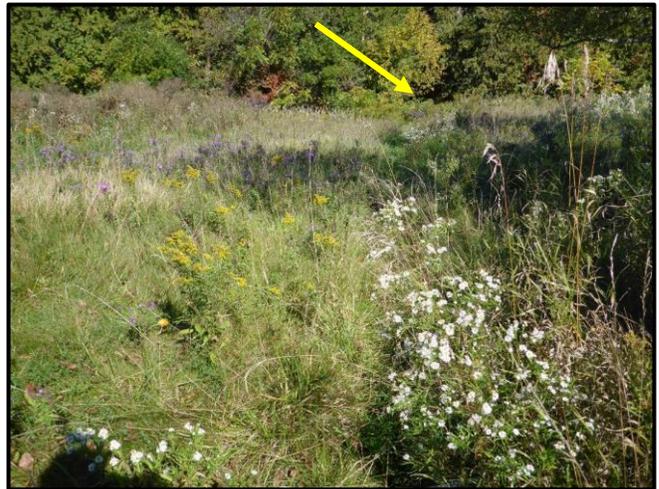
Surface Flow - Photo 84 (Location 81)
Downstream view of surface drainage feature.

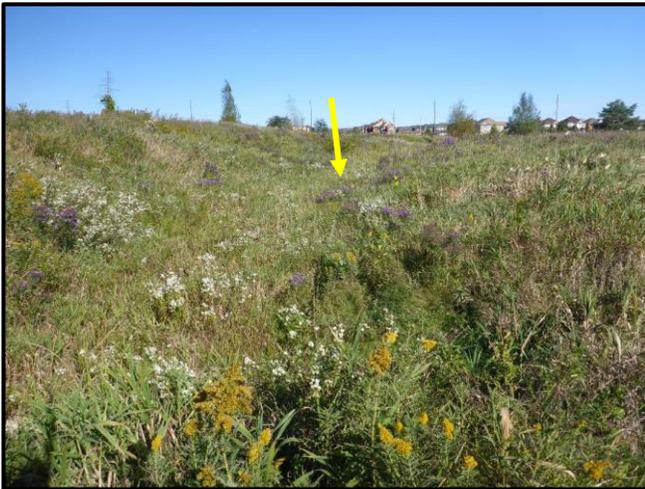
Surface Flow - Photo 87 (Location 83)
Upstream view of surface drainage feature.

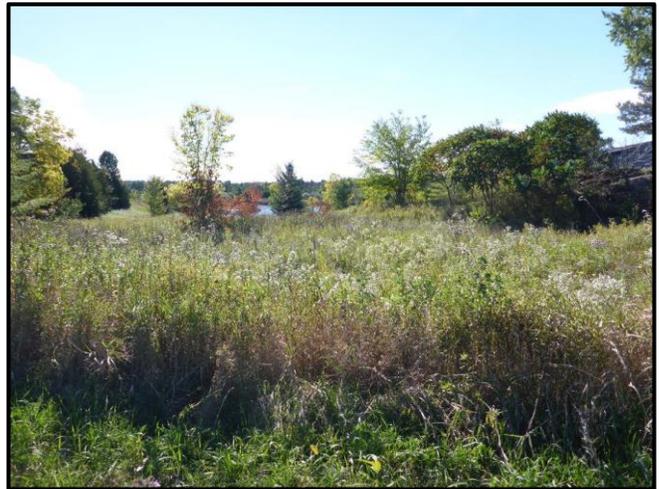
Surface Flow - Photo 88 (Location 84)
Downstream view of surface drainage feature (towards Pond H).

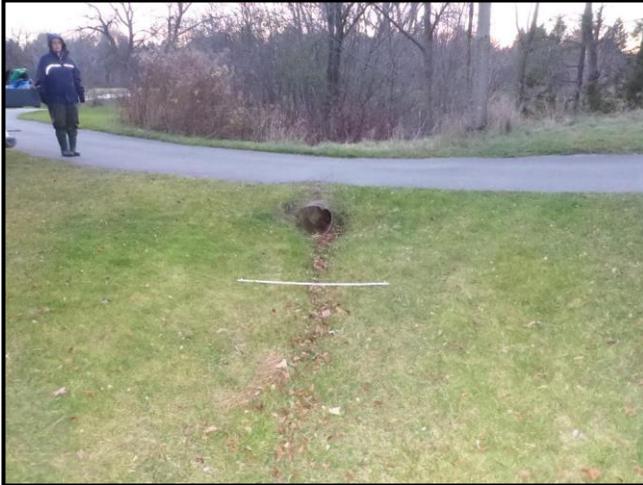
**Surface flow - Photo 89 (Location 85)
Downstream of overland conveyance area and
existing culvert under cart path.**

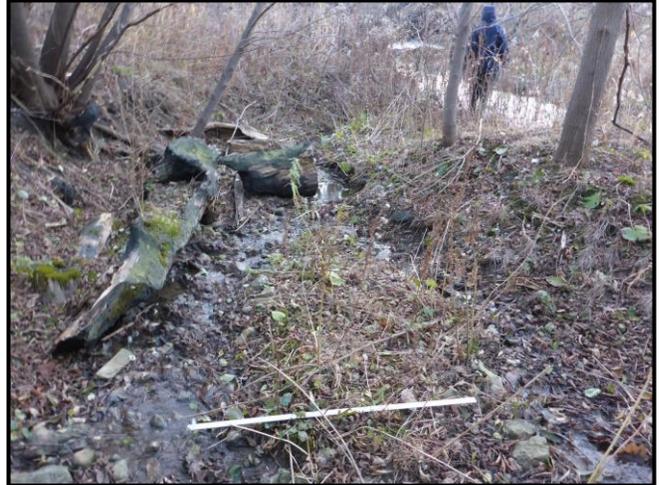
**Surface Flow - Photo 90 (Location 86)
Upstream view of surface drainage feature.**
